Site CBSS9C: McNutt Brook

Date Assessed: 06/28/02

Road Crossing: Culvert, corrugated steel

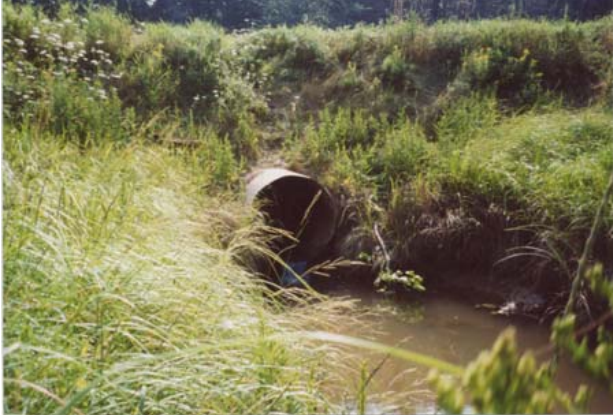
Figure 1.

Crossing Condition: Structure is intact.

Restriction Indicators:

Difference in stream width

Difference in water level

Bank slumping

Scour pool

Comments: Replace culvert with a larger opening.

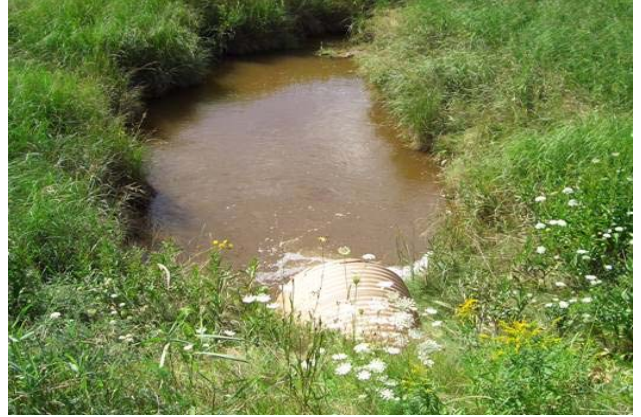
Figure 2.

Downstream of Crossing

Creek: 4.9m wide with smooth, straight flow.

Land: Residential, unused agricultural land with marsh vegetation evident.

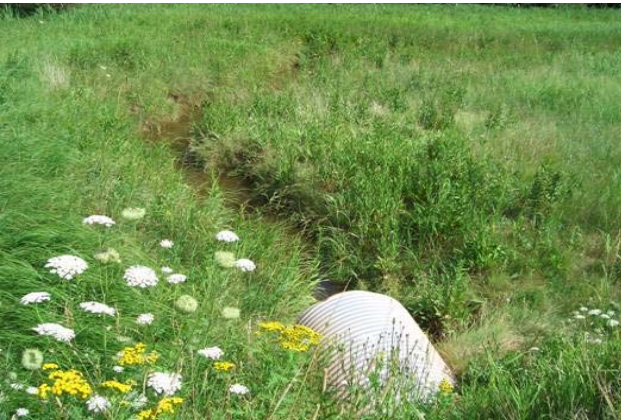
Figure 3.

Upstream of Crossing

Creek: ~1.2m wide with smooth, straight flow.

Land: Marshland and wooded area.
