Site SH3C: Fisher Creek

Date Assessed: 10/07/02

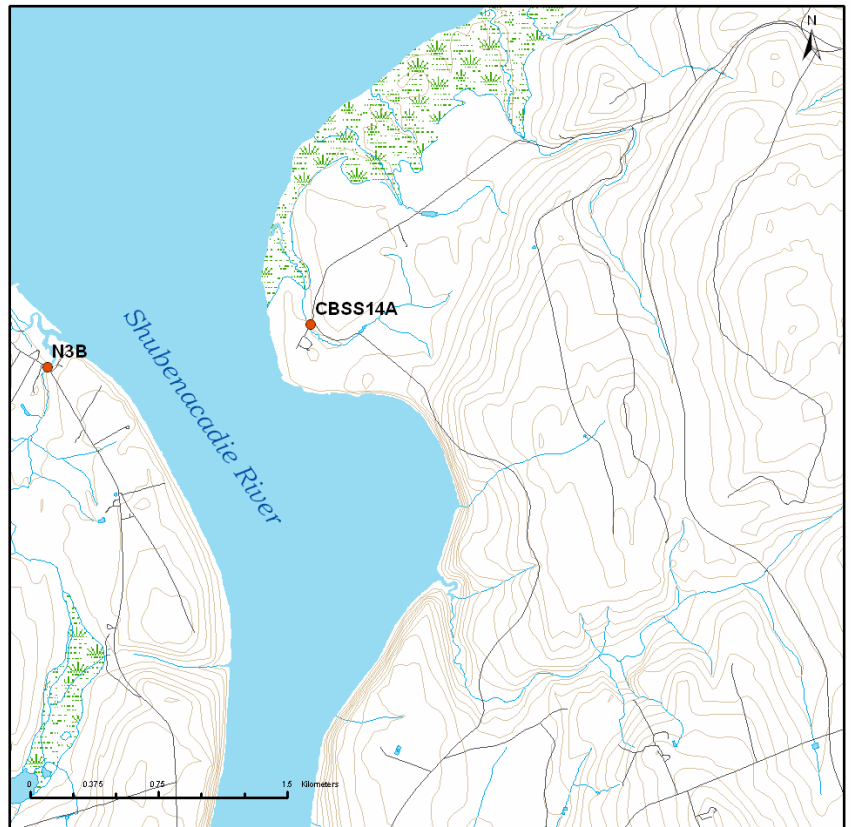
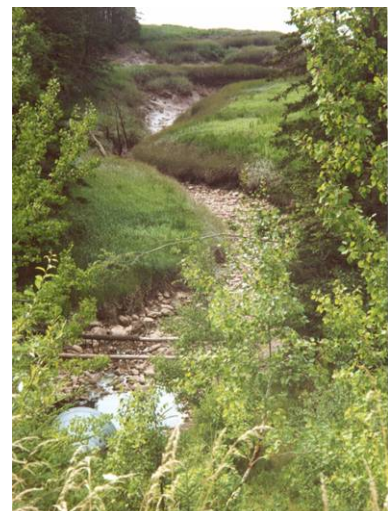
Figure 1

Road Crossing: Culvert, corrugated, 2.6m in diameter. The culvert could not be accessed on the downstream end.

Crossing Condition: Intact

Restriction Indicators:
Difference in vegetation
Bank slumping

Comments: Culvert diameter is smaller than the stream width causing a partial restriction to tidal flow. Opening could be enlarged.
