Site ST7C: McKay Siding (Stewiacke River tributary) **Date Assessed:** 21/06/02

Crossing Status: Partial Restriction

Road Crossing: Culvert, wooden, 2m

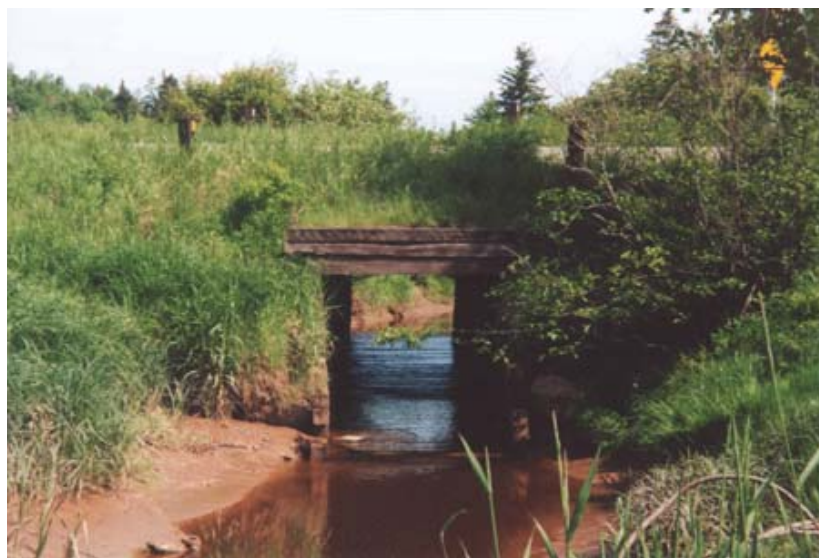
Figure 1

Crossing Condition: Intact

Restriction Indicators:
 Difference in stream width

Comments: This crossing is not causing a large restriction to flow however the crossing is smaller than the width of the river. The opening should be enlarged when repairs are made.
