Site TA2B: Salmon River (Park Street)

Date Assessed: 06/19/02

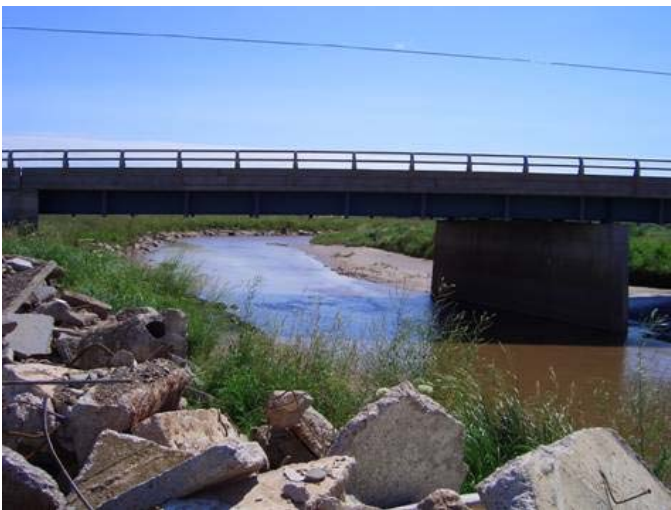
Figure 1

Crossing Condition: Structure is intact.

Comments: Structure is not restricting tidal flow, maintain size of opening

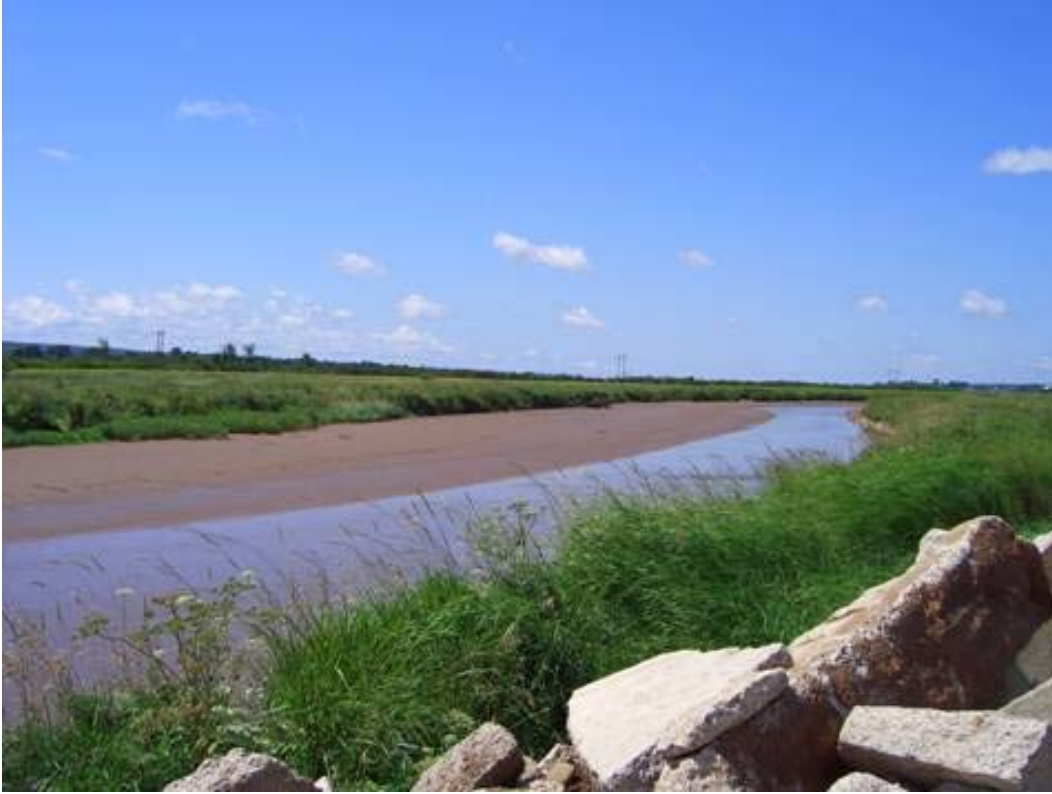
Figure 2

Creek: 37m wide, smooth, straight flow.

Land: Agricultural with mixed commercial land use.

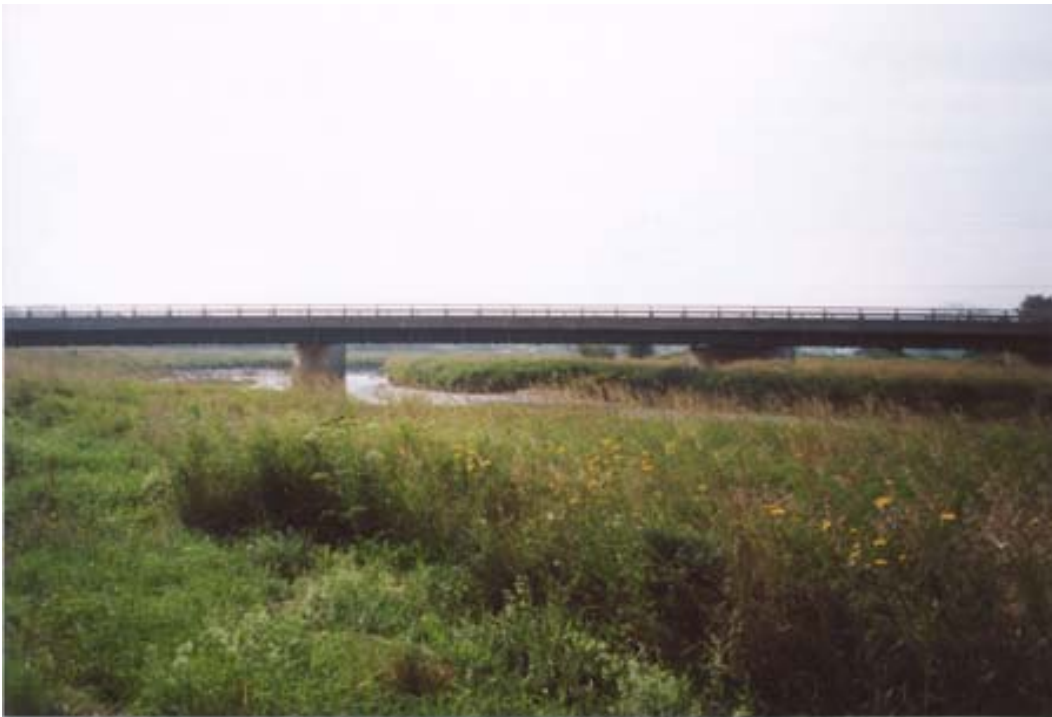
Figure 3

Creek: 36.1m wide, smooth, straight flow.

Land: Dykes present along river, industrial land use, mixed with recreational.
