Site TA3B: Salmon River (Main Street)

Date Assessed: 06/19/02

Road Crossing: Bridge, steel, 41m wide

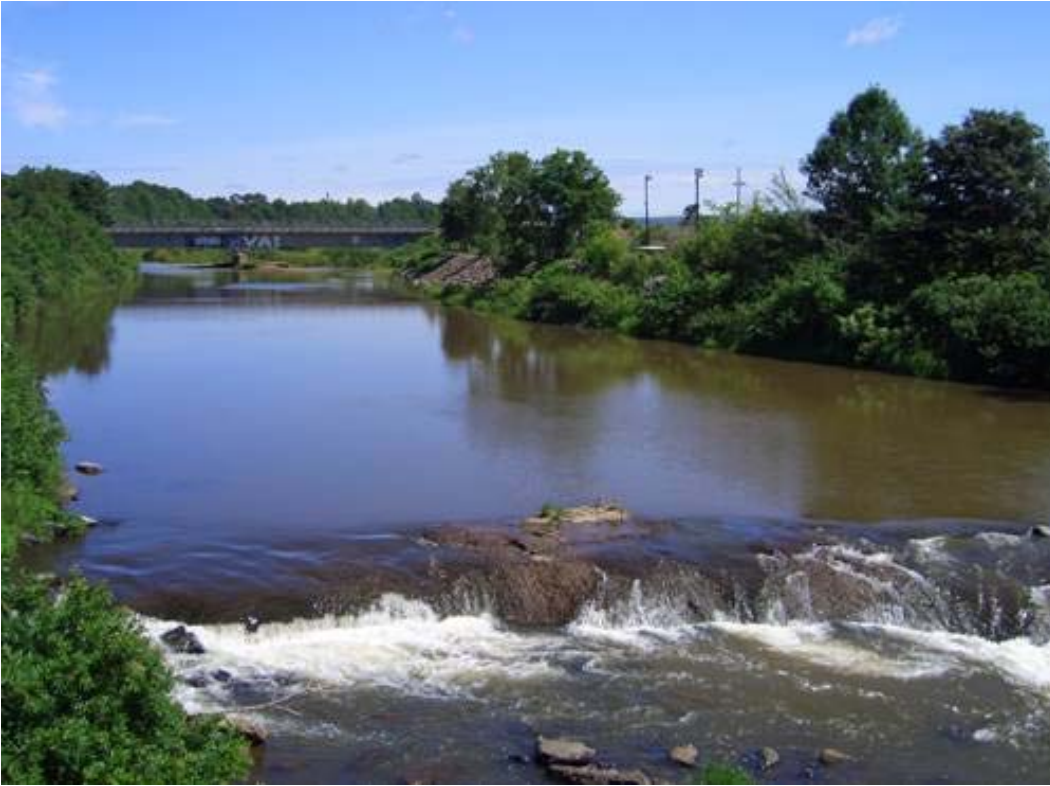
Figure 1

Crossing Condition: Structure is intact.

Comments: Concrete wall (~25m) on one side of downstream bank to prevent erosion.
