Site CCCB 17C: Minudie/Barronsfield

Date Assessed: July 8, Aug. 27-8,
Nov. 18, 2003

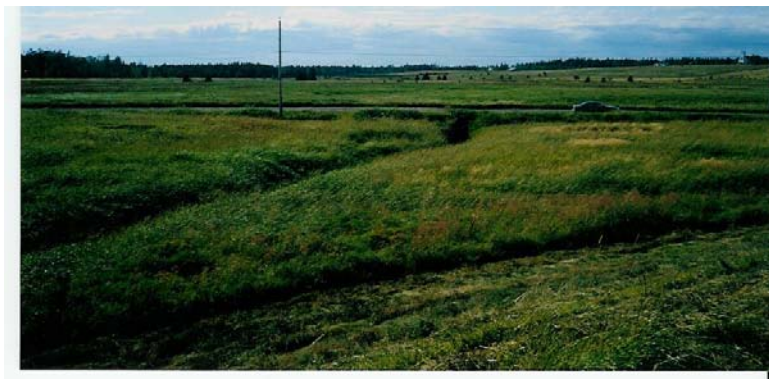
Road Crossing: Wooden box culvert,
1.5m by 1m.

Crossing Condition: Starting to
collapse on top.

Figure 1. Looking towards road and crossing from the top of the dyke.

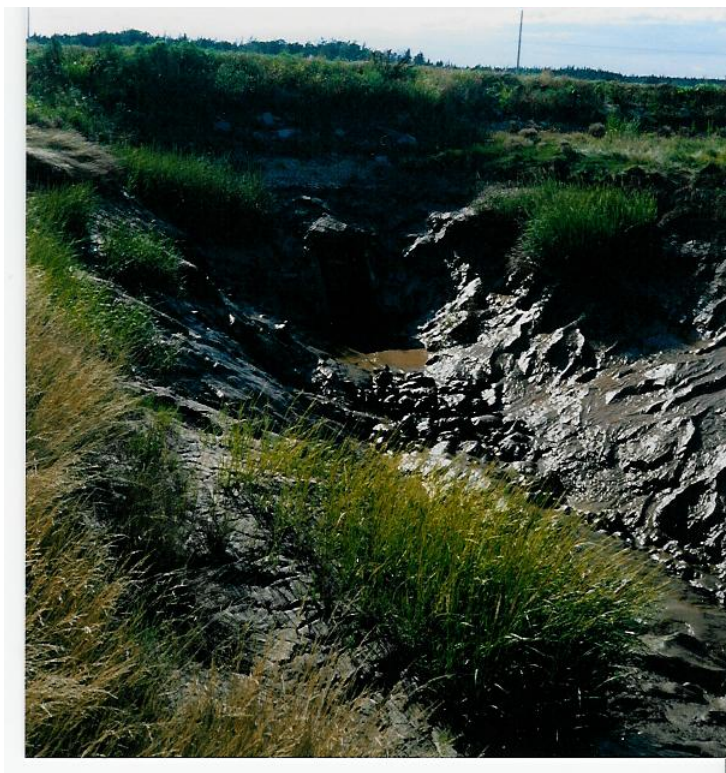
Land: Agricultural land. There is a
large dyke with an aboiteau restricting
tidal flow.

Figure 2. Downstream of the large dyke and aboiteau.

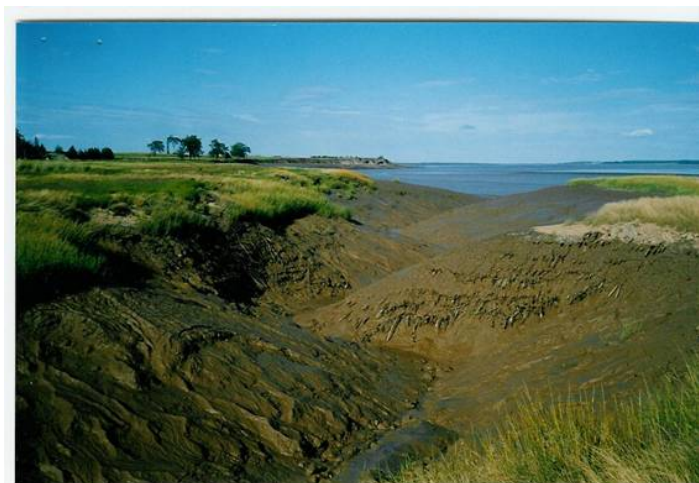
Figure 3. Downstream of the dyke. There are remnants of the old dyke. Photo was taken standing on the dyke.
