Site CCCB 20B: Shulie River

Date Assessed: July 8, Aug. 27-8,
Nov. 18, 2003

Road Crossing: A 17m long steel
and wood bridge.

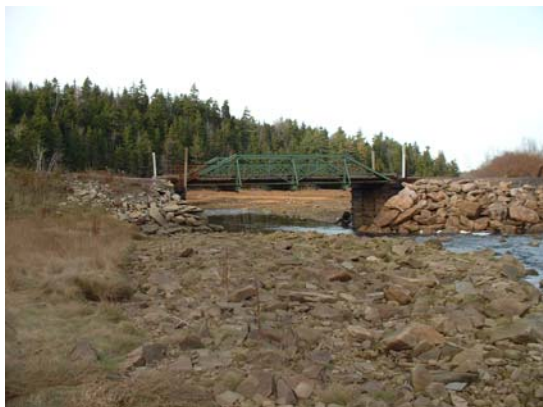
Restriction Indicators:
Difference in stream width
Turbulent water flow
Slack water
Divergent channel

Figure 1. Downstream of the bridge clearly showing the build up of the banks with boulders.

Comments: Maintain or enlarge opening when replacing and consider realignment with original channel path.

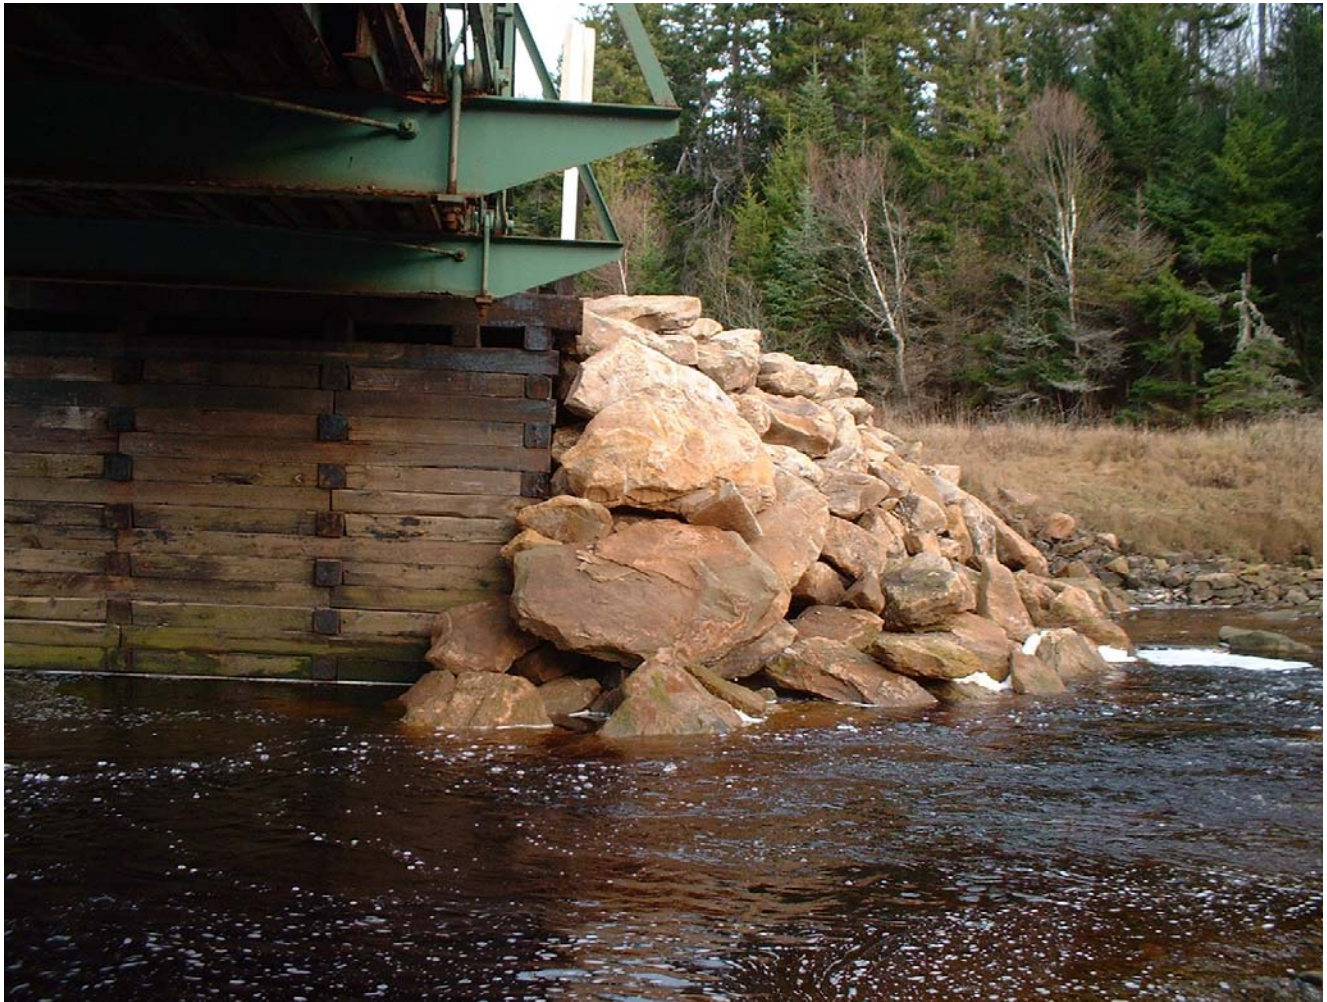
Figure 2. The boulder supports.
