Site CCCB 2B: LaPlanche River (Amherst)

Date Assessed: 01/08/03

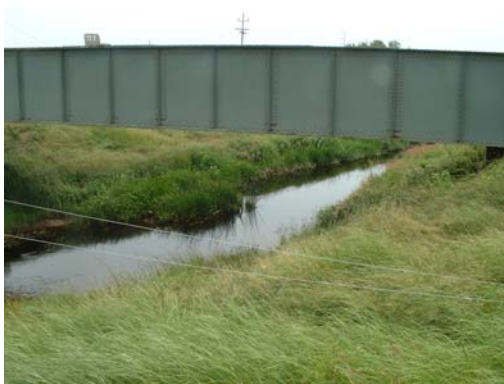
Crossing Condition: Structure is intact.

Figure 1. The rail bridge as seen from the road.

Comments: When repair or replacement is necessary, maintain the size of the opening. If downstream obstructions are removed, a re-evaluation of the crossing should be done. Evaluate adjacent and downstream land use and address downstream restriction.

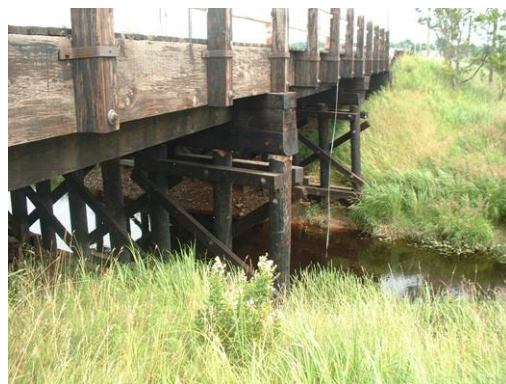
Road Crossing: Two bridges, 30m long wooden bridge (road), and adjacent rail bridge.

Figure 2. The road bridge.
