Site CCCB 3B: LaPlanche River (Amherst Hwy 104)

Date Assessed: 01/08/03

Road Crossing: Two 30m long concrete bridges (divided highway).

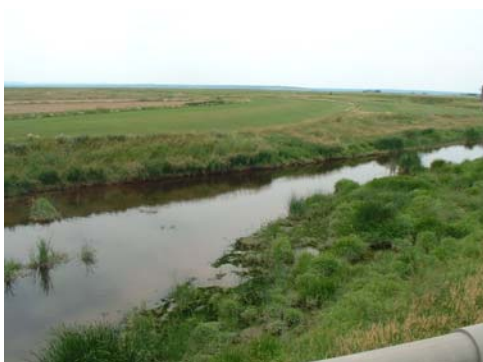
Crossing Status: No longer tidal.

Land: Actively being farmed.

Figure 1. Downstream of the crossing is being actively farmed and is no longer tidal.

Comments: When repair or replacement is necessary, maintain the size of the opening. If obstructions downstream are removed, a new assessment of the crossing should be done. Evaluate land use and downstream obstructions for potential remediation or removal.

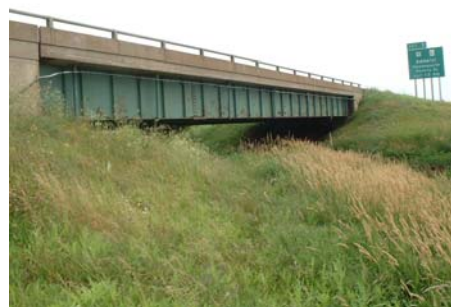
Crossing Condition: Structures are intact.

Figure 2. The bridge as seen from the upstream bank.
