Site CCCB 4A: Nappan River

Date Assessed: July 8, Aug. 27-8,
Nov. 18, 2003

Road Crossing: 7m wide double
chambered concrete aboiteau with steel
gates.

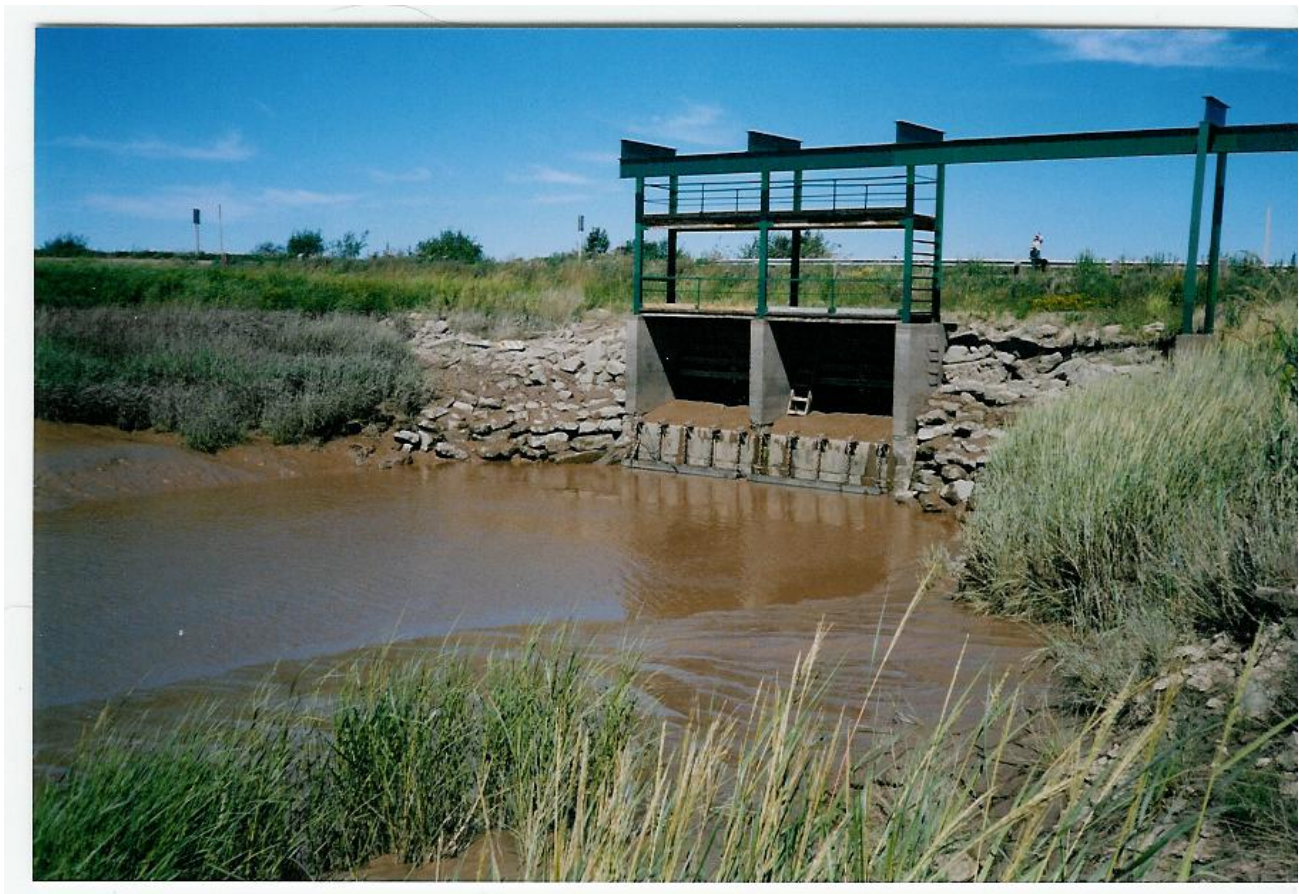
Creek: 30m wide creek with a pool at
the base of the aboiteau.

Land: Agricultural cropland, dykeland.

Figure 2. Downstream of crossing.

Comments: Area up and downstream continues to be actively farmed. DOAF controlled aboiteaux regulates water level upstream and dykes along river downstream protect farmland. Crossing could be assessed for impacts to fish passage. If fish are using system, how much of a barrier is the aboiteaux presenting.
