Site CCCB 7B: Little Forks River (Athol)

Date Assessed: July 8, Aug. 27-8,
Nov. 18, 2003

Road Crossing: 32m long steel bridge.

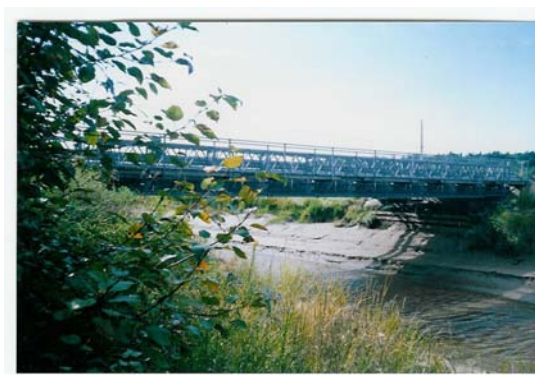
Crossing Condition: Structure is intact.

Figure 1. Non restrictive, one lane bridge. Photo taken from upstream bank.

Comments: When repair or replacement is needed, maintain the size of the opening.

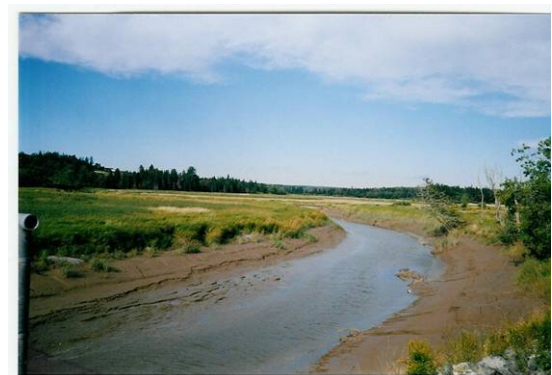
Creek: 25m wide with a smooth, straight flow and salt marsh vegetation along banks.

Figure 2. Downstream of the bridge, taken from the bridge.

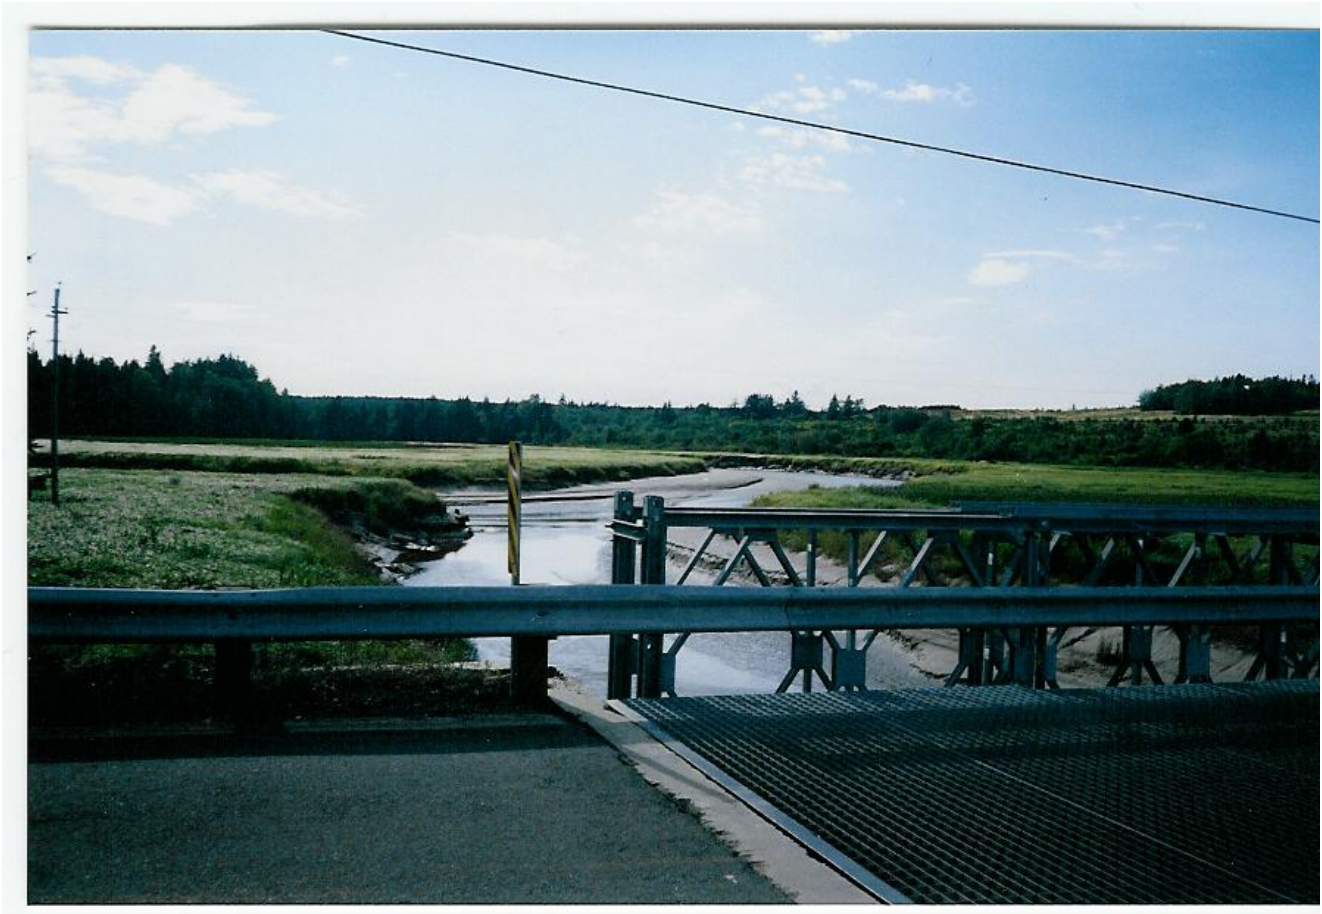
Creek: 25m wide with a smooth, straight flow and salt marsh vegetation along banks that quickly changes to fresh water vegetation.

Figure 3. Upstream of the bridge.
