Site CCCB 8B: Maccan River (Hwy 242)

Date Assessed: July 8, Aug. 27-8,  
Nov. 18, 2003

Road Crossing: 80m long concrete bridge.

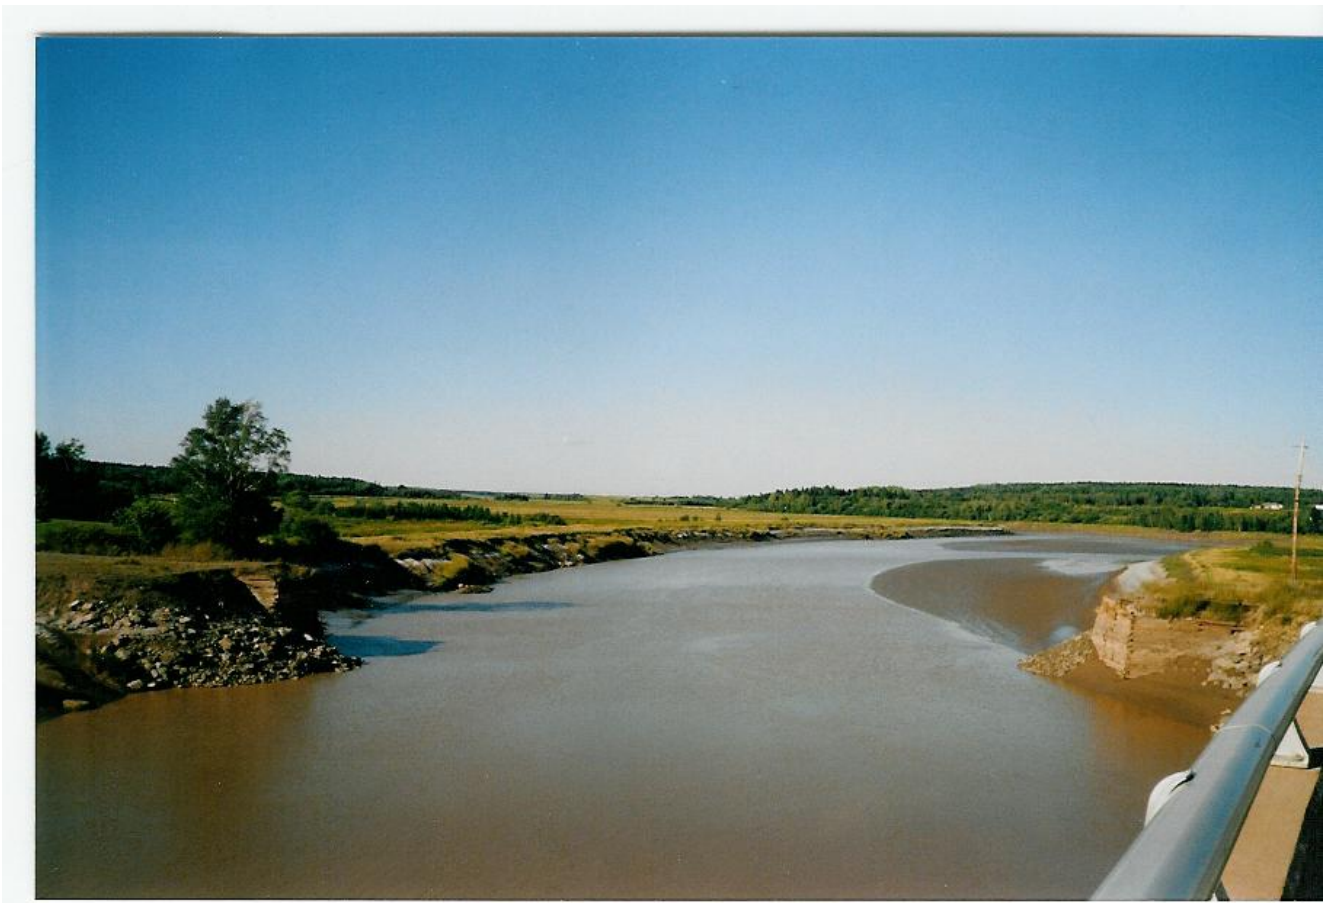
Figure 2. Downstream of the bridge. Remnants of the old bridge are visible. Can see some of the dyking downstream.
