Site CCMC 27A: Spencer’s Island

Date Assessed: July 8, Aug. 27-8,  
Nov. 18, 2003

Road Crossing: 1.5m wide wooden  
aboiteau.

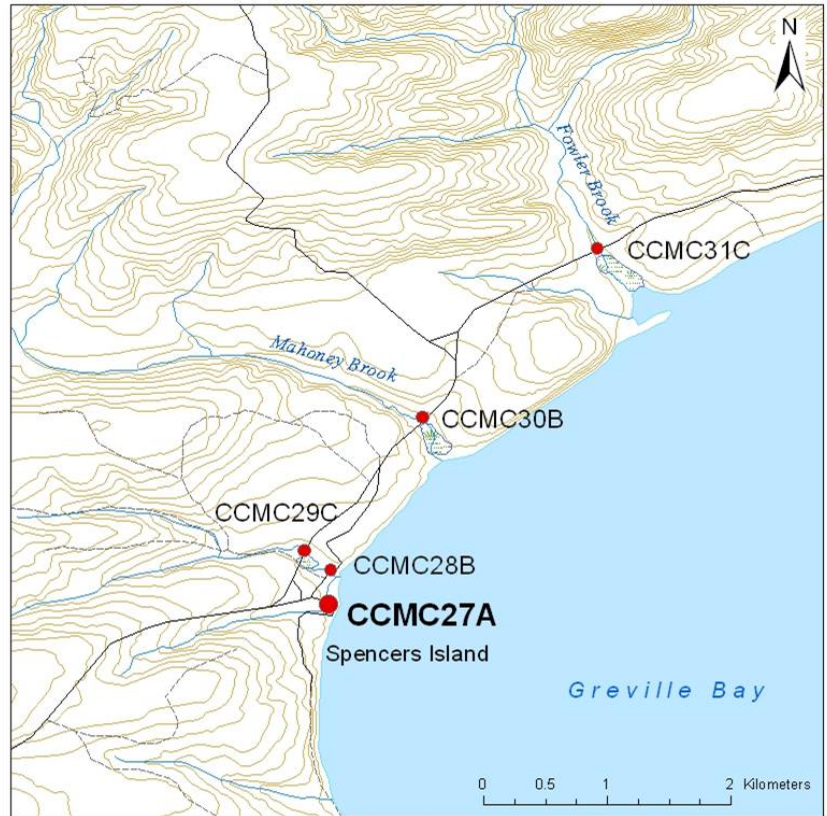
Crossing Status: Complete restriction.

Crossing Condition: Gate is broken,  
wedged partially open. Tide gate is  
lodged in place and allowing for very  
limited flow and may contribute to  
upstream flooding during peak runoff  
periods.

- Restriction Indicators:
- Difference in water levels
  - Scour pool
  - Difference in stream width
  - Structure failure
  - Difference in vegetation
  - Aboiteau/tide gate

Comments: Remove broken gate, enlarge opening

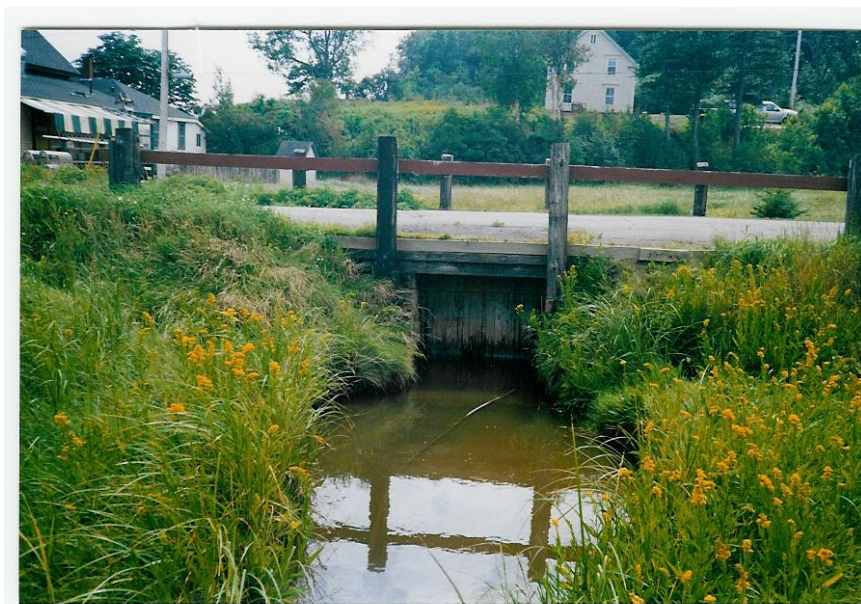
Figure 1.  
Downstream end of the crossing. The broken gate is visible. It is allowing some tidal flow, but should be removed to eliminate the small amount of pooling.

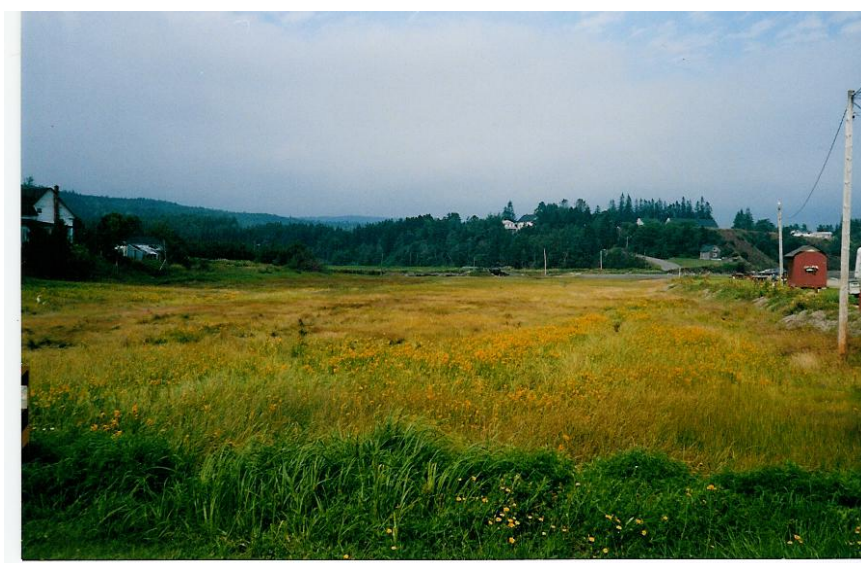
Land: Salt marsh. Channel flows from the main channel leading to CCMC28B.

Figure 2.  
Downstream marsh with the campground to the right that is located along open edge of barrier beach.
