Site CCMC 28B: Spencer's Island

Date Assessed: July 8, Aug. 27-8,  
Nov. 18, 2003

Road Crossing: 5.5m long wooden bridge.

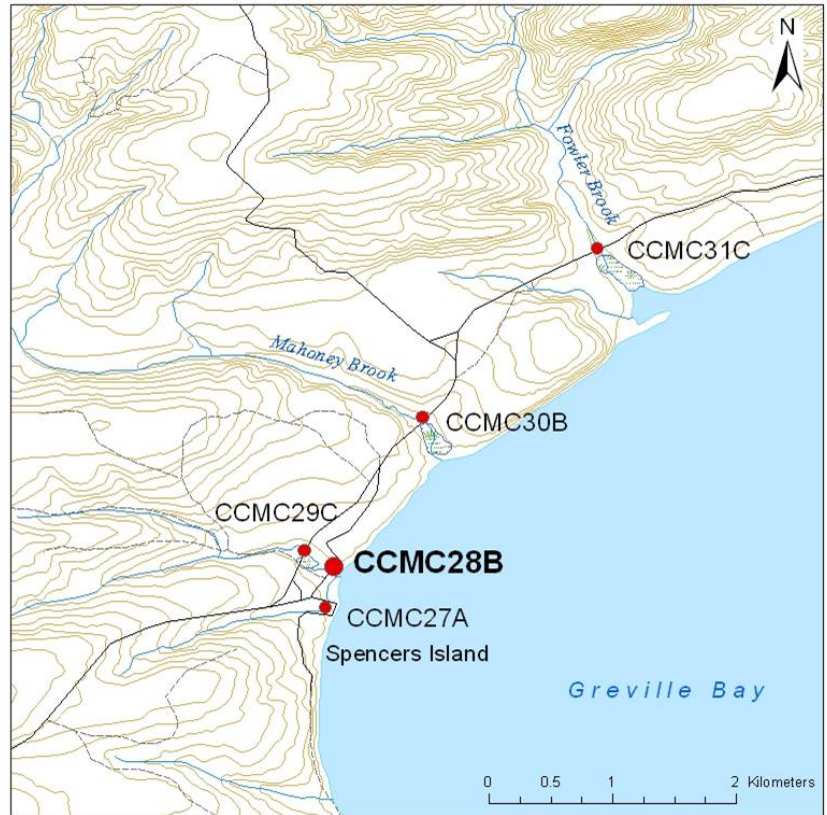
Crossing Condition: Original structure is intact.

Restriction Indicators:  
Difference in stream width  
Bank Slumping  
Scour pool

Creek: Approximately twice as wide as the opening, with evidence of bank erosion and scour pool, but the flow is relatively smooth.

Creek: Approximately twice as wide as the opening, with evidence of bank erosion, but the flow is relatively smooth.

Comments: Maintain or enlarge opening size when repairing or replacing. Enlarging this opening would increase tidal flow to upstream area and between and beyond this crossing and CCMC 28A and 29C (This crossing is seaward opening that provides tidal flow to the marsh area and creeks leading to CCMC 28A and 29C).

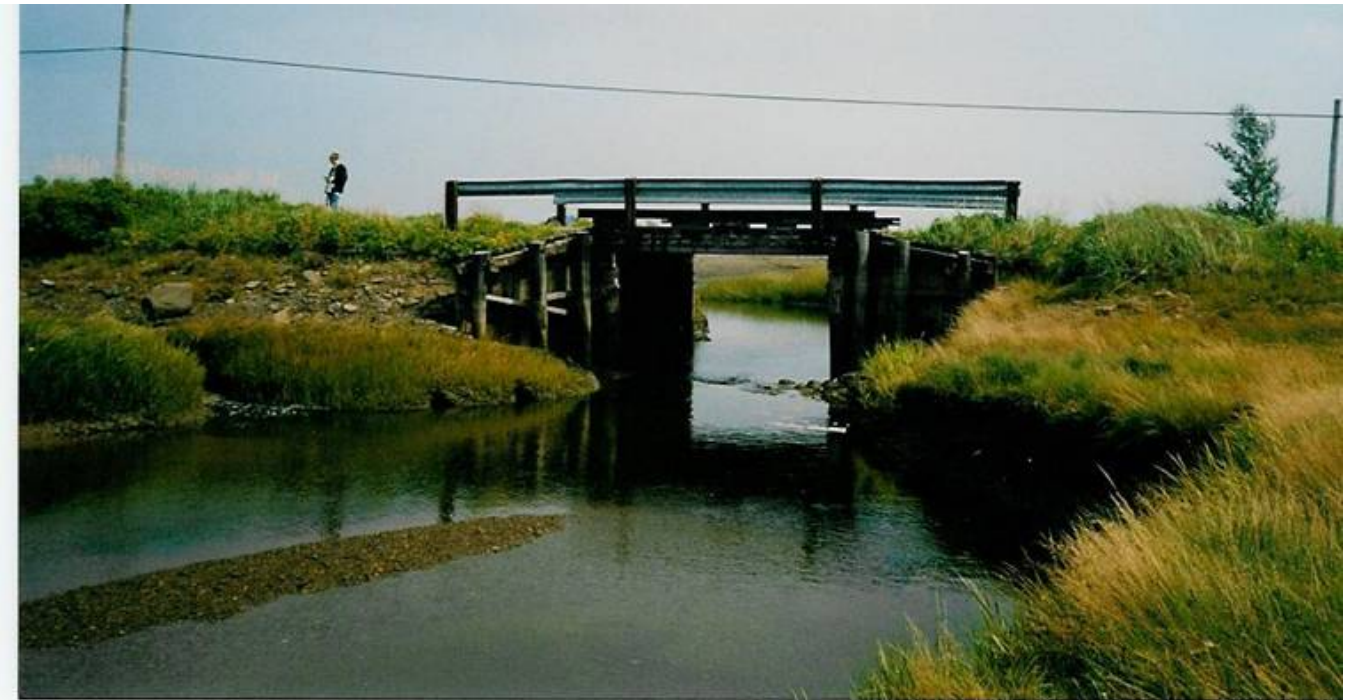
Land: Salt marsh.

Figure 1. Upstream of the crossing with lots of salt marsh vegetation.
