Site CCMC 30B: Mahoney Brook

Date Assessed: July 8, Aug. 27-8,  
Nov. 18, 2003

Road Crossing: 16m long wooden bridge.

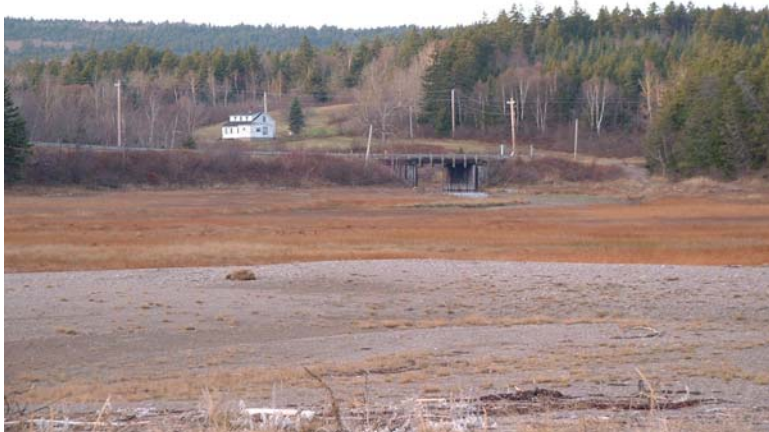
Crossing Condition: Appears to have been Recently repaired.

Comments: There is no tidal restriction of the channel.

Figure 1. The crossing as seen from the downstream beach.

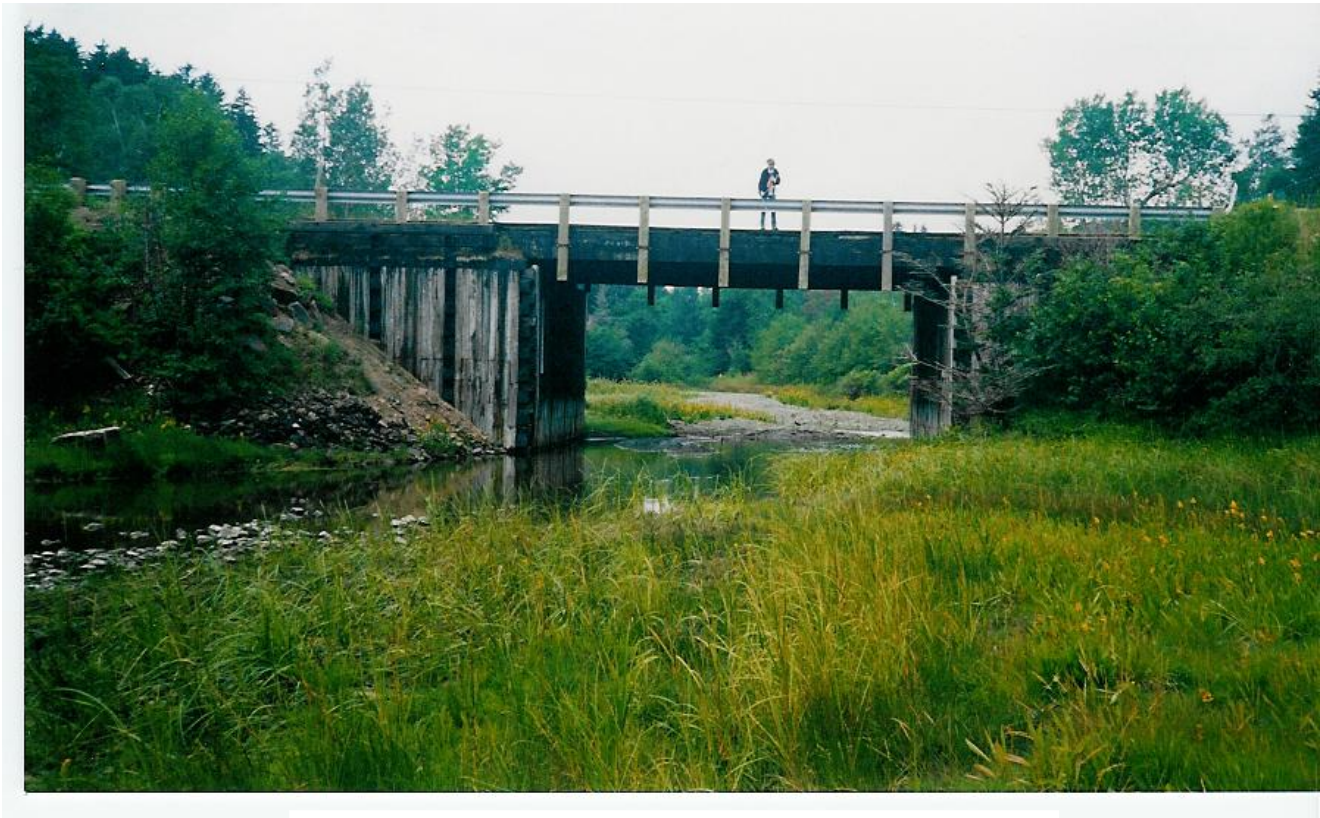
Figure 2. Closer downstream view of the crossing.
