Site CCMC 36A: Parrsboro Aboiteau

Date Assessed: July 8, Aug. 27-8,
Nov. 18, 2003

Road Crossing: A large causeway with a 21m sluice gate opening.

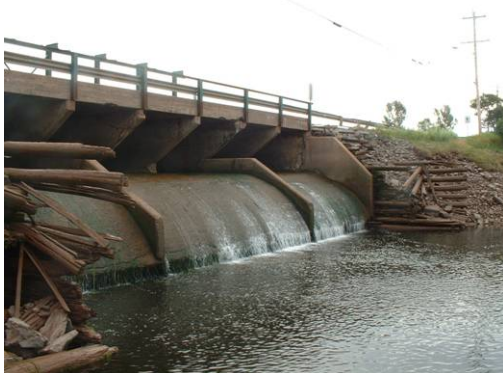
Creek: Channel is 30m wide, with substantial bank erosion and turbulent flow.

Figure 1. Downstream view of the structure.

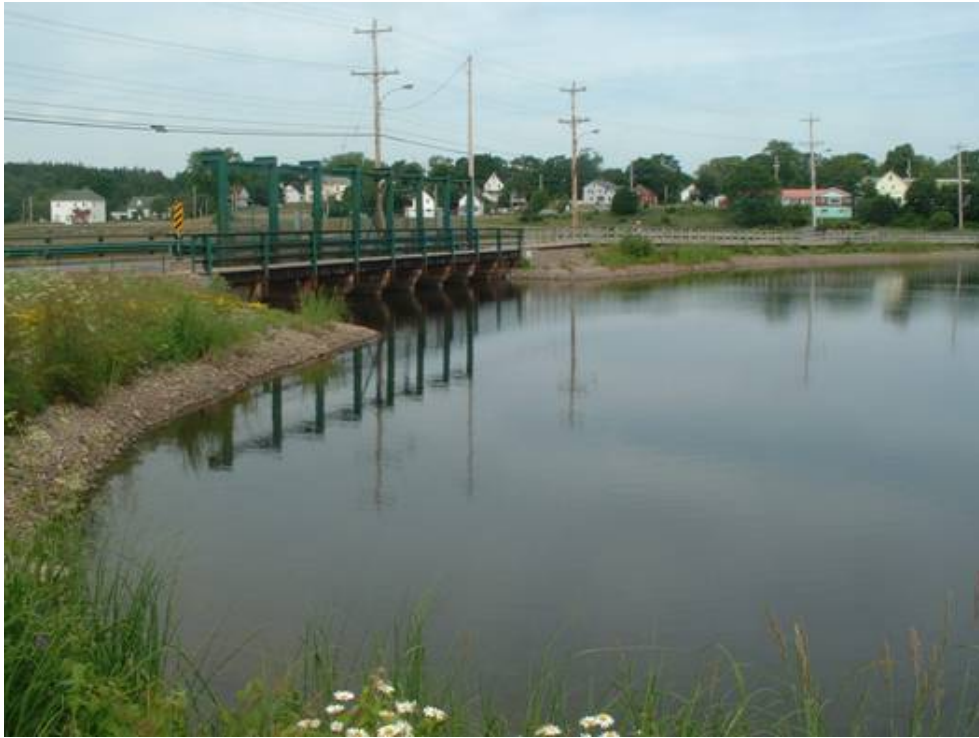
Creek: Head pond, approximately four times as wide as the sluice gate opening.

Figure 2. Upstream of causeway and dam structure with head pond.

Comments: Given the infringement of buildings along or near the banks of the channel, restoring tidal flow may not be an option. Fish passage should be addressed.
