Site DC13C: Little Joggins

Date Assessed: 26/08/04

Crossing Status: Partial restriction

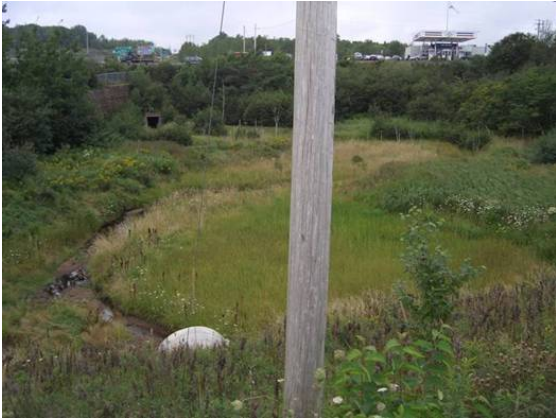
Creek: 1m wide, straight flow. Square concrete culvert just upstream which extends under highway 303.

Figure 1. Upstream of crossing there is a square culvert passing under Hwy 303.

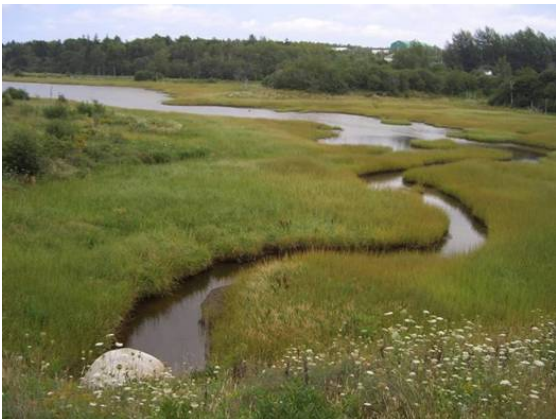
Creek: 3m wide, straight flowing. Further downstream there is a causeway which crosses near the mouth of Little Joggins.

Figure 2. Downstream of crossing

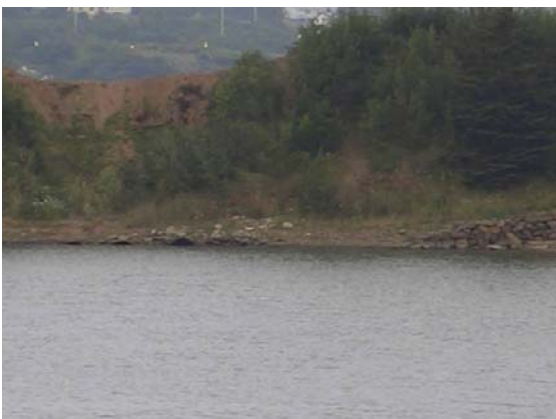
Figure 3. Further downstream of crossing there is a causeway separating this area from the Basin. Could not access this barrier or assess any culvert(s) underneath it.

Comments: There is a slight restriction by this culvert but tidal flow would not be greatly increased by enlarging this opening due to the downstream restriction (causeway). This extensive barrier downstream could not be assessed due to construction. This causeway would need to be assessed and determine if it contains any culverts and how much of an effect it is having on tidal flow and fish passage.
