Site DC15C: Westport

Date Assessed: 26/08/04

Road Crossing: Culvert (corrugated), 1.5m

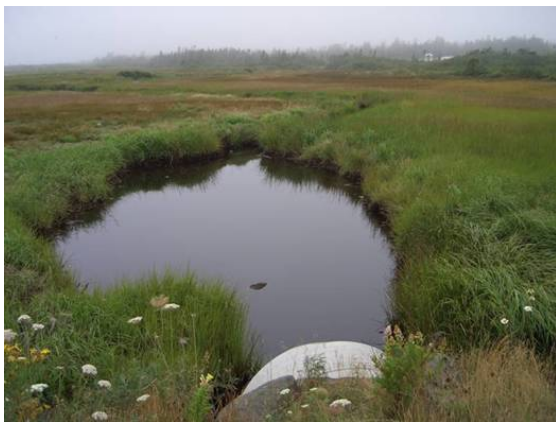
Figure 1. Upstream of crossing

Creek: Opens into bay.

Land: Beach and seawall.

Comments: Replace culvert with a larger opening to increase salt marsh habitat.

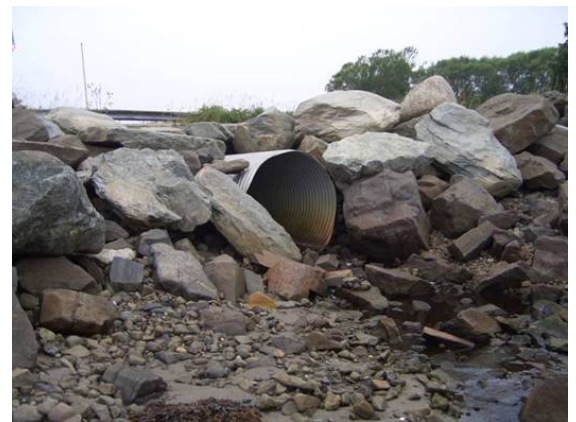
Figure 2. Downstream view of crossing

- Difference in water levels
- Difference in stream width
- Scour pool

Creek: 1m wide creek with 6m scour pool formed at mouth of crossing.

Land: Salt marsh, residential, bordered by storage facility.
