Site DC17C: Long Island Brook

Date Assessed: 26/08/04

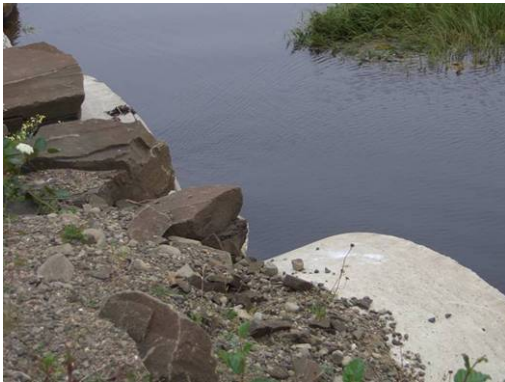
Figure 1. Upstream view of crossing

- Difference in stream width
- Difference in water level
- Scour pool

Creek: 15m wide with large scour pool to the right of the crossing.

Comments: Tidal flow would be improved with a single opening, possibly a bridge.

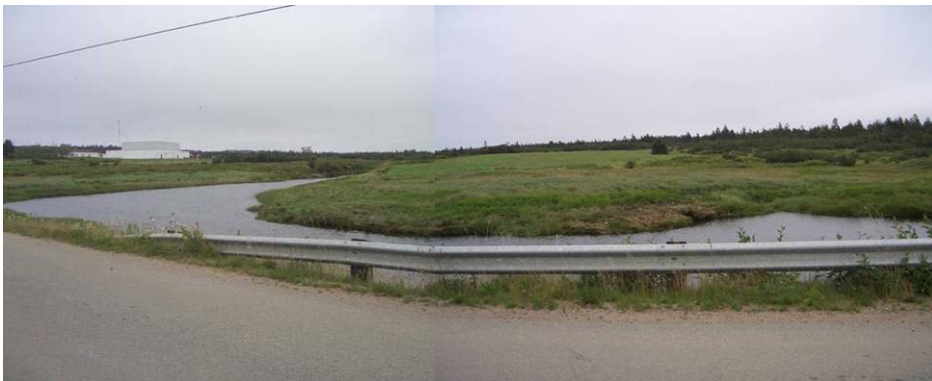
Figure 2. Upstream of crossing

Land: Residential.
