Site DC21A: Post Brook

Date Assessed: 26/08/04

Crossing Status: Complete restriction

Road Crossing: Aboiteau (upstream side: concrete/square with two round openings)

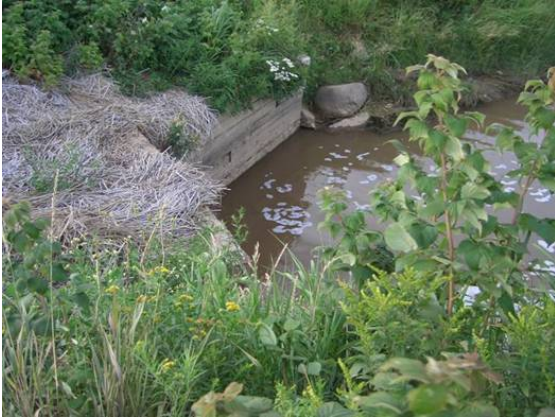
Figure 1. Upstream view of crossing

Crossing Condition: Intact

- Difference in water level
- Aboiteau/tide gate
- Difference in stream width
- Turbulent flow
- Difference in vegetation

Comments: This land is currently being used for farming and cattle grazing therefore replacement of the aboiteau may not be possible. Should the land no longer be used for this purpose the aboiteau should be replaced with a culvert to restore natural flooding and fish passage. This crossing should be considered along with crossing DC22A since they affect the same area of farmland.

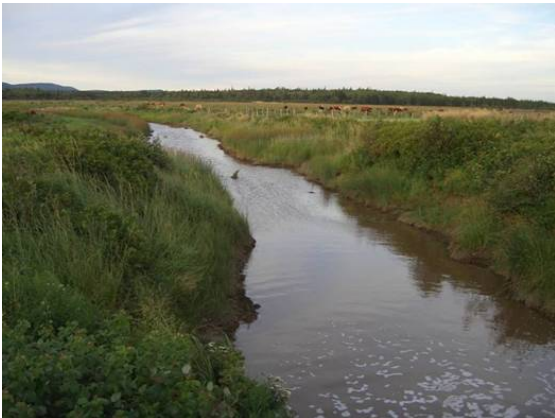
Figure 2. Upstream of crossing

Creek: 6m wide.

Land: Agricultural dykeland.
