Site DC24B: Kinney Brook (Gilberts Cove)

Date Assessed: 26/08/04

Crossing Status: Partial restriction

Road Crossing: Bridge (wooden), 18m

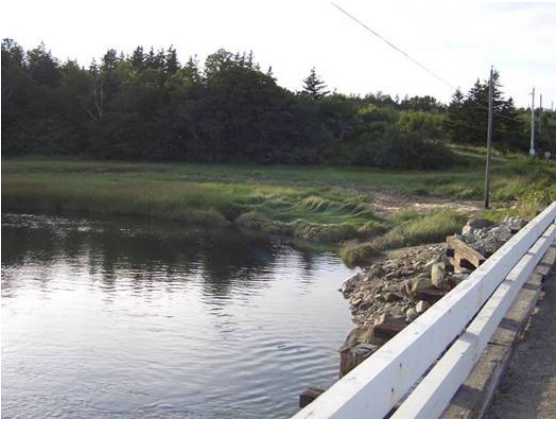
Figure 1. Upstream view of crossing

Crossing Condition: Intact

- Difference in stream width
- Scour pool
- Turbulent flow

Comments: Since this bridge opening is large in size and only poses a slight restriction there may not be any potential for restoration at this site. When repair is required opening size should at the very least be maintained and rock pile under bridge be excavated.
