**Site DC25B:** Kinney Brook (Gilberts Cove)

**Date Assessed:** 26/08/04

**Road Crossing:** Bridge (wooden)

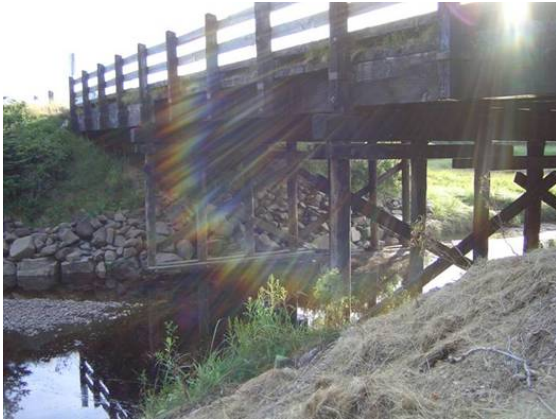
**Figure 1.** Upstream view of crossing

**Crossing Condition:** Intact

**Restriction Indicators:** None

**Comments:** Little restriction to flow or fish passage, maintain size of opening when repair is necessary.

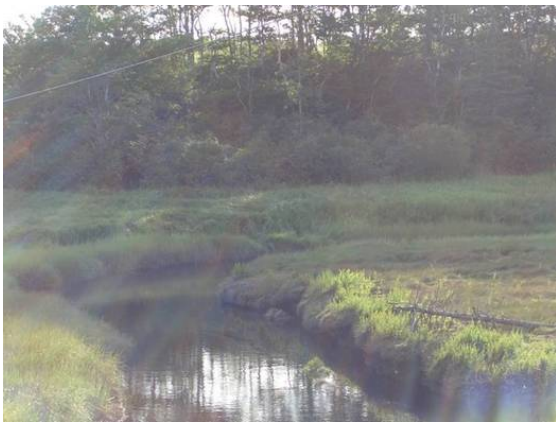
**Figure 2.** Downstream of crossing

**Creek:** 6m wide smooth, straight flow.

**Land:** Small salt marsh.

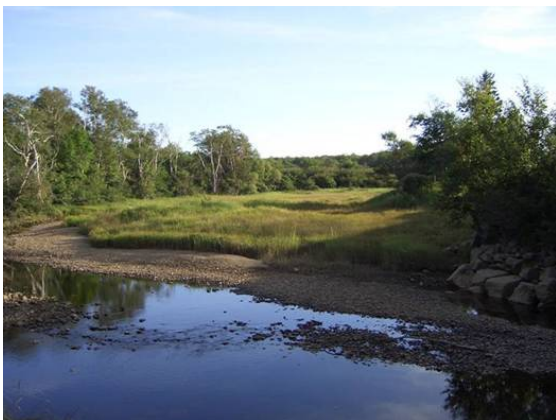
**Figure 3.** Upstream of crossing

**Creek:** 8m wide smooth flow with small scour pool, upstream of DC24B.

**Land:** Small salt marsh.
