Site DC31B: Grosses Coques River

Date Assessed: 26/08/04

Road Crossing: Bridge (concrete), 8.6m opening

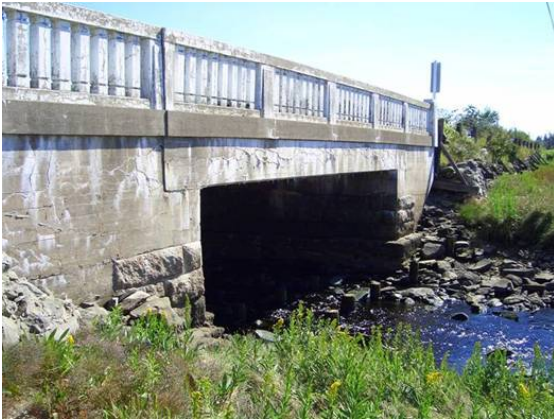
Figure 1. Downstream view of crossing

Creek: 15m wide, bank slumping, scour pools, eddies and slack water.

Land: Salt marsh.

Comments: Consideration should be made to widening this bridge opening as this is a fairly large salt marsh area and the bridge is pinching the river. .

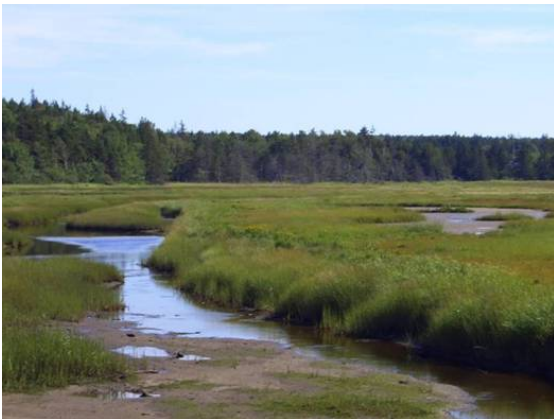
Figure 2. Upstream of crossing

Creek: 12m wide, bank slumping, scour pools smooth flow with slack water. Flows into crossings DC32C and DC33B.

Land: Salt marsh.
