**Site DC32C:** Grosses Coques River

**Date Assessed:** 26/08/04

**Crossing Status:** Partial restriction

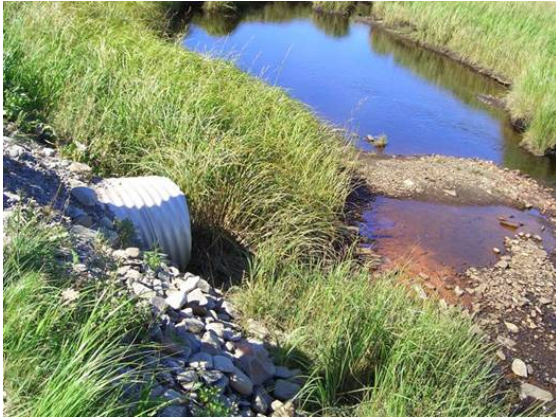
**Figure 1.** Downstream view of crossing

**Creek:** 5m width at opening, scour pools, slack water and angular flow.

**Land:** Salt marsh.

**Comments:** Crossing size should be enlarged to improve tidal flow and fish passage. Stream width is reduced on the upstream side of the crossing due to the small culvert opening.

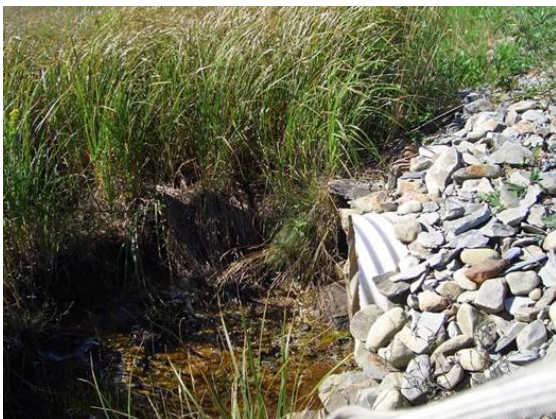
**Figure 3.** Upstream view of crossing

**Creek:** 0.5m width at opening, scour pools, slack water and angular flow.

**Land:** Salt marsh.
