**Site DC3B:** Bear River

**Date Assessed:** 26/08/04

**Road Crossing:** Bridge (concrete), 18m opening

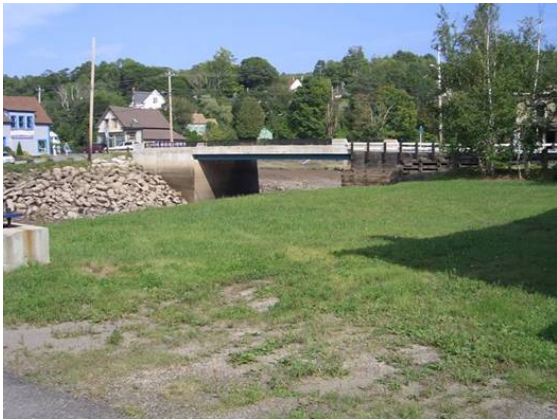
**Figure 1.** Downstream view of crossing

**Comments:** This bridge does not span the width of the river, however it is large enough that it does not pose as a significant restriction to tidal flow or fish passage. It does pinch the river slightly, however water level and stream width remain constant on both sides. When repair is necessary opening should at the very least be maintained.

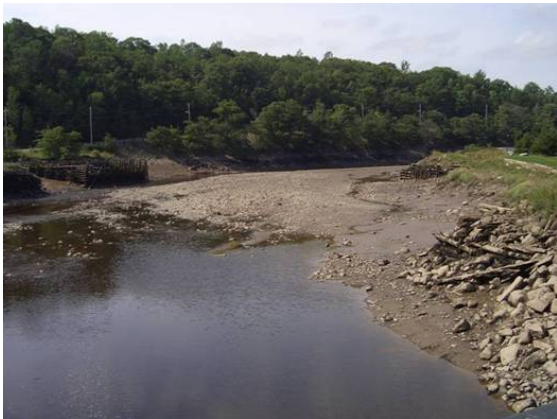
**Figure 2.** Downstream of crossing

**Creek:** 35m wide, smooth straight flow, scour pool.

**Land:** Edge salt marsh, old wharf, residential and business.

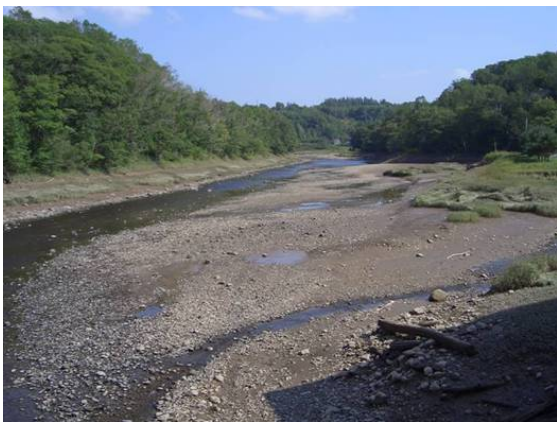
**Figure 3.** Upstream of crossing

**Creek:** 35m wide, smooth straight flow, scour pool.

**Land:** Edge salt marsh, bordered by forest.
