**Site DC4B:** Harris Brook (Bear River tributary)

**Date Assessed:** 26/08/04

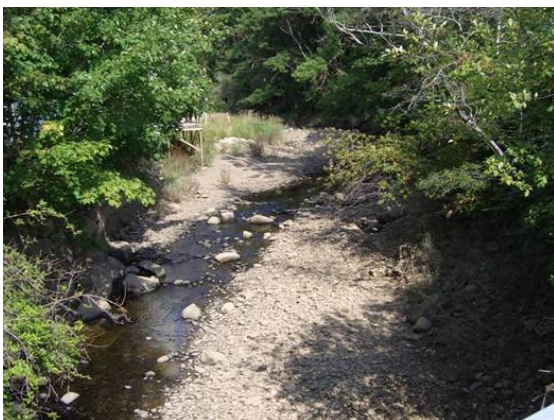
**Figure 1.** Upstream of crossing

**Comments:** This crossing is essential a house on stilts acting as a bridge. The opening spans the width of the creek and poses no restriction to tidal flow or fish passage. There is a rise in elevation upstream and no salt marsh vegetation.
