Site DC5B: Wade Brook (Bear River tributary)

Date Assessed: 26/08/04

Crossing Status: Partial restriction

Road Crossing: Bridge (concrete), 7m, with old dam structure (concrete), 1-2m opening

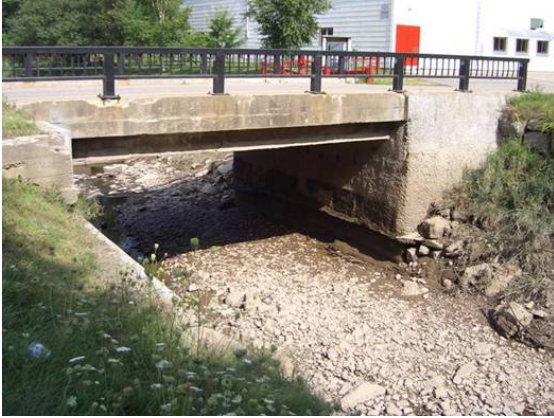
Figure 1. Downstream view of crossing

- Difference in stream width
- Difference in water levels
- Scour pool

Creek: 8m wide tributary of Bear River, scour pool.

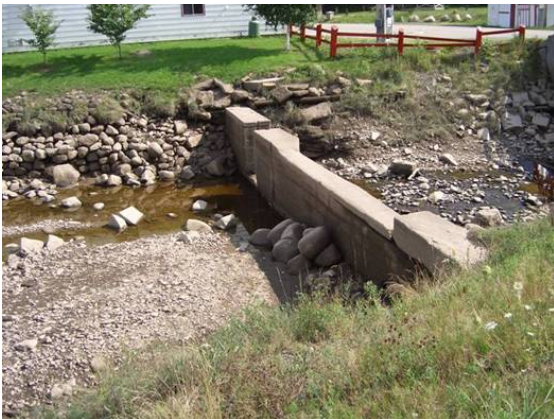
Figure 2. Dam just downstream of crossing

Comments: The bridge spans the width of the creek and poses not restriction to tidal flow, however there is an concrete dam structure with a 1-2m wide opening that is restricting tidal flow and fish passage to the upstream. The purpose and function of this structure needs to be assessed and the possibility of removing it.

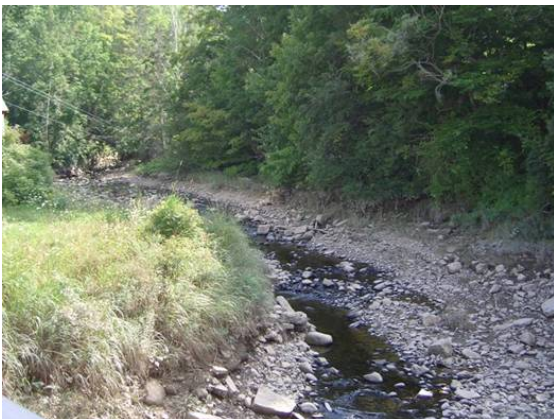
Figure 3. Upstream of crossing

Creek: 7m wide tributary of Bear River, smooth straight flow.
