Site DC8B: Roach Brook (Smiths Cove)

Date Assessed: 26/08/04

Road Crossing: Bridge (concrete), 14m

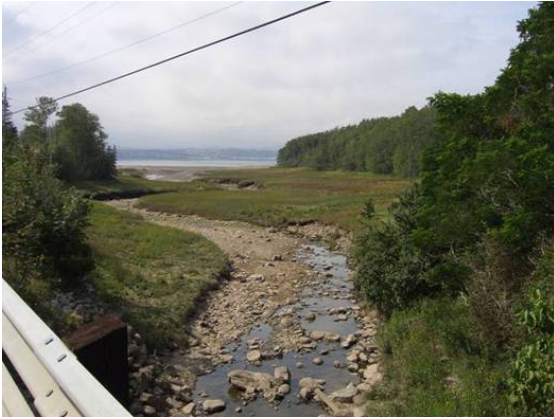
Figure 1. Downstream of crossing

Downstream of Crossing

Creek: 8m wide straight flow.

Land: Salt marsh and residential.

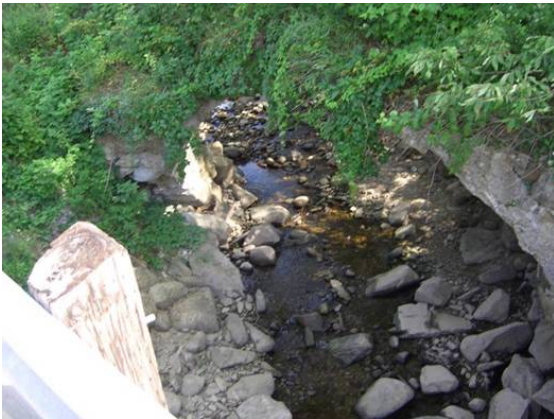
Figure 2. Upstream of crossing

Upstream of Crossing

Creek: 6m wide straight flow, rise in elevation just past crossing.

Land: Wooded and residential. There are remnants of an old concrete bridge structure and a culvert just upstream possibly part of an old road. These do not appear restricting.

Comments: Maintain size of opening when repairs are made.

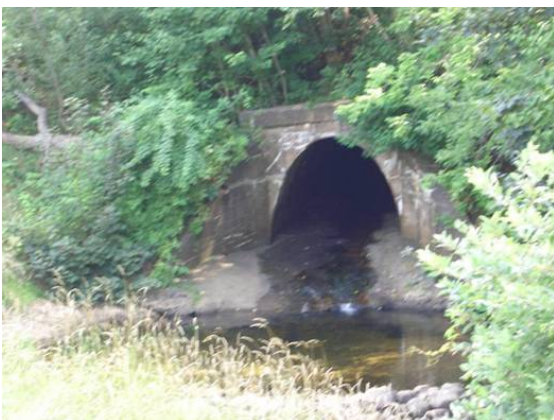
Figure 3. Upstream open bottom concrete culvert in an old road crossing which does not appear to be restricting.
