Site DC9B: Big Joggins

Date Assessed: 26/08/04

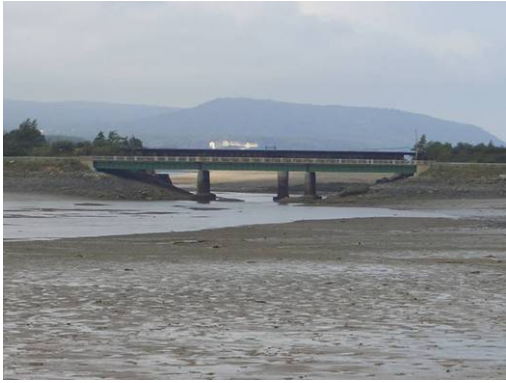
Figure 1. Upstream view of crossing

Comments: This bridge is large enough that it is not causing a restriction to tidal flow or fish passage. There is however a slight pinching of the river. Excavation of the banks around the base of the bridge could be considered.

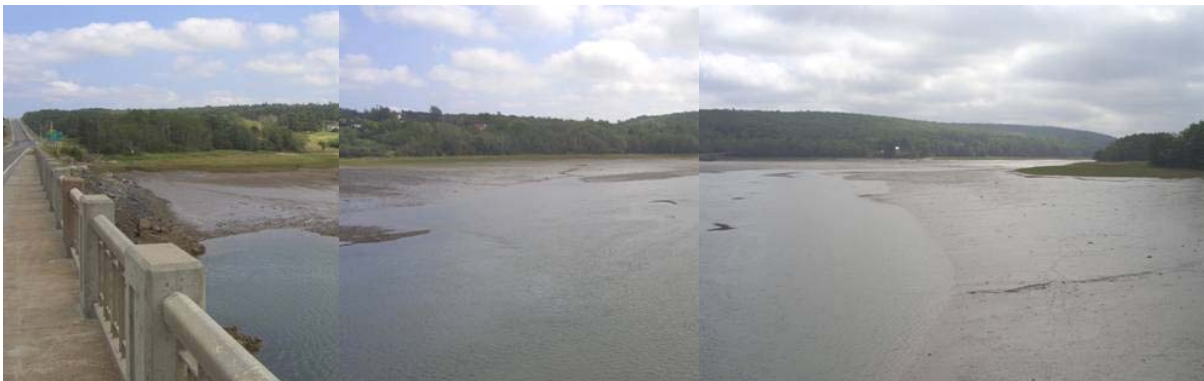
Figure 3. Upstream of crossing

Land: Large mudflats during low tide, some marsh vegetation along edges, bordered by forested area.
