Site N10C: Noel Marsh

Date Assessed: 08/05/01

Crossing Status: Partial restriction

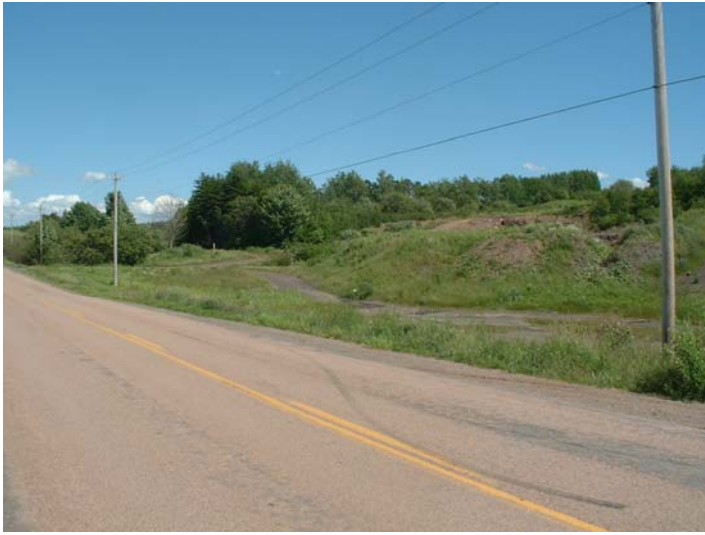
Figure 1. Upstream

Creek: Straight flow

Land: Gravel fill, parking area

Comments: Culvert should be lowered and channel cleared. Debris was piled in front of opening. Fresh water drainage.

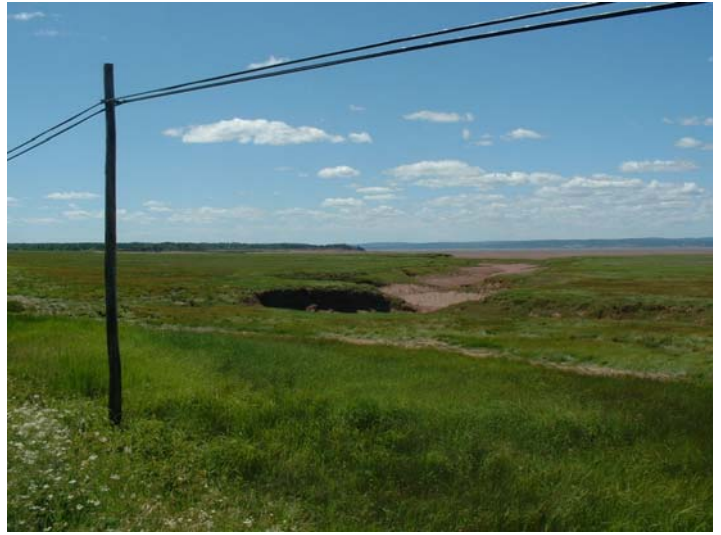
Figure 2. Downstream

Crossing Condition: intact, debris blocking opening

Creek: 1 ½ m wide, slack water, path appears divergent from original
