Site N14C: Tenecape

Date Assessed: 08/05/01

Road Crossing: Culvert (wooden box) 2 chambers, 5m total

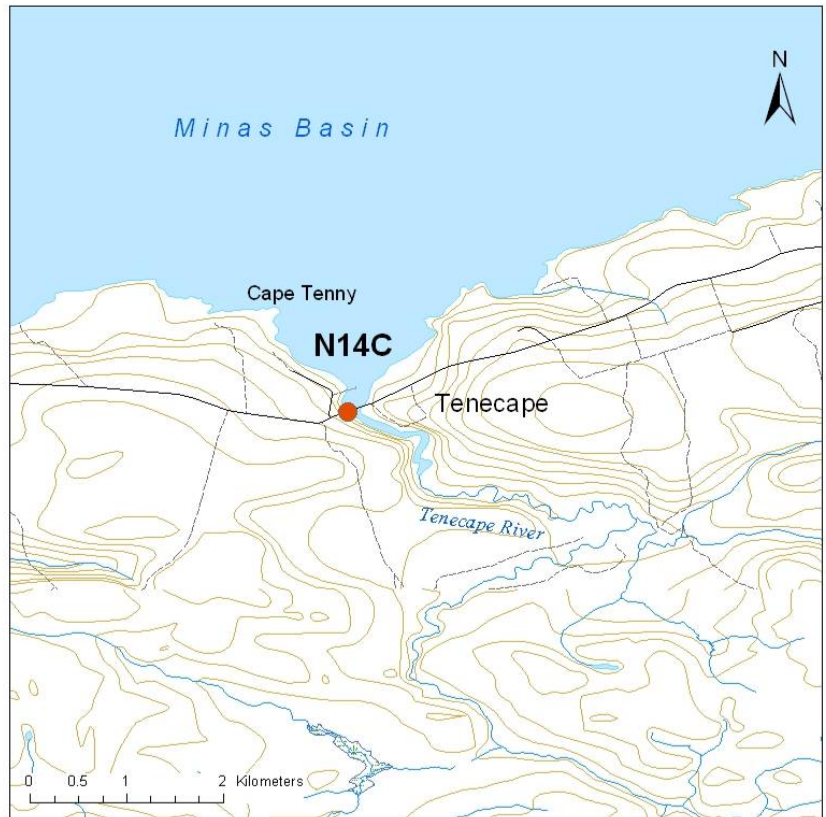
Comments: This site is a complete restriction to tidal flow and fish passage as the culvert has been placed too high to allow tidal flow upstream, with only freshwater outflow. Due to culvert placement the channel is being diverted and the river is undercutting the embankment. The rock base under the seaside opening is eroding. Culvert needs to be replaced with a lower and larger opening, possible a bridge since this is a large system and once a salmon river.
