Site N17B: Bass Creek

Date Assessed: 15/05/01

Road Crossing: Bridge (wooden)

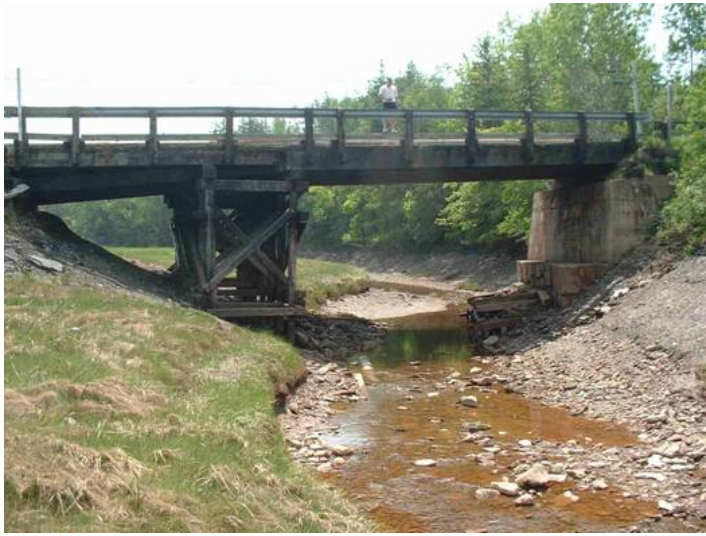
Crossing Condition: some support failure, in need of site cleanup

Figure 1. Downstream view of crossing

Comments: Bridge could use some repairs and a clean up of this site to remove debris.

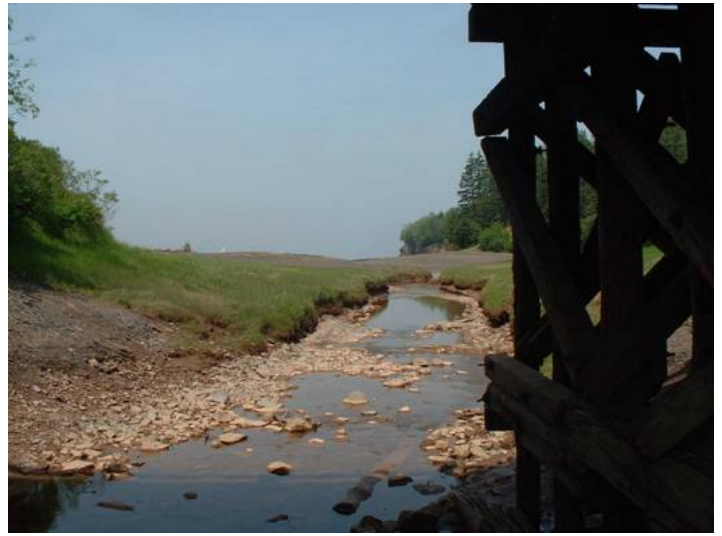
Creek: 10m wide smooth, straight flow, some bank slumping

Land: Salt marsh, rocky beach

Figure 2. Downstream of crossing

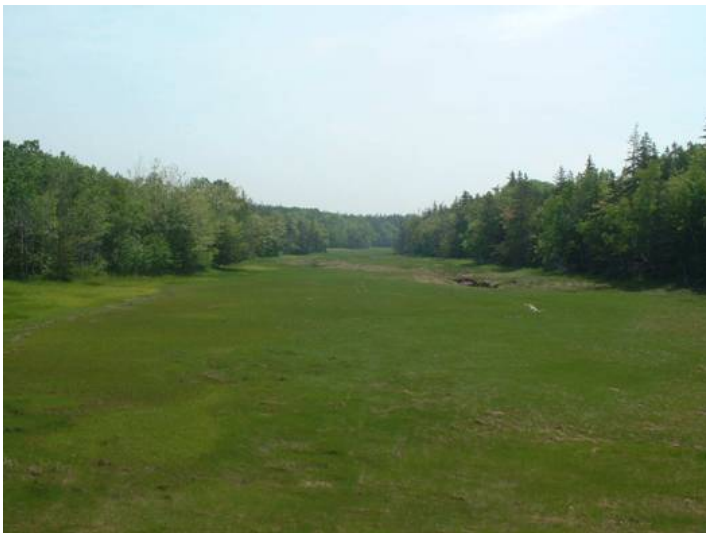
Creek: 10m wide smooth, straight flow, some bank slumping

Land: Salt marsh

Figure 3. Upstream of crossing
