Site N4C: Selma

Road Crossing: Culvert (wooden box), 1m

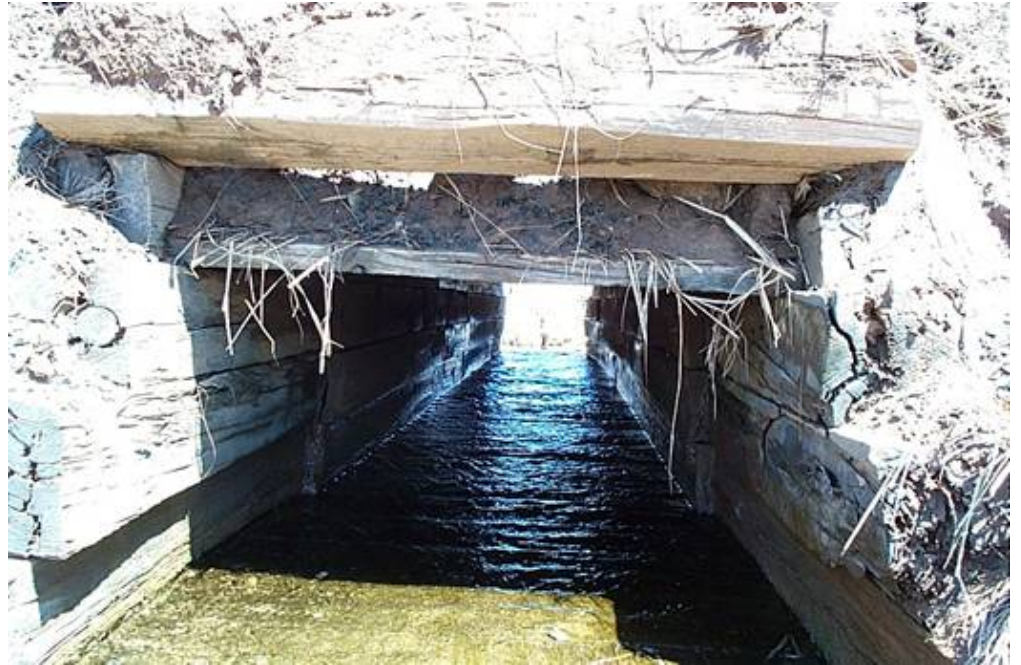
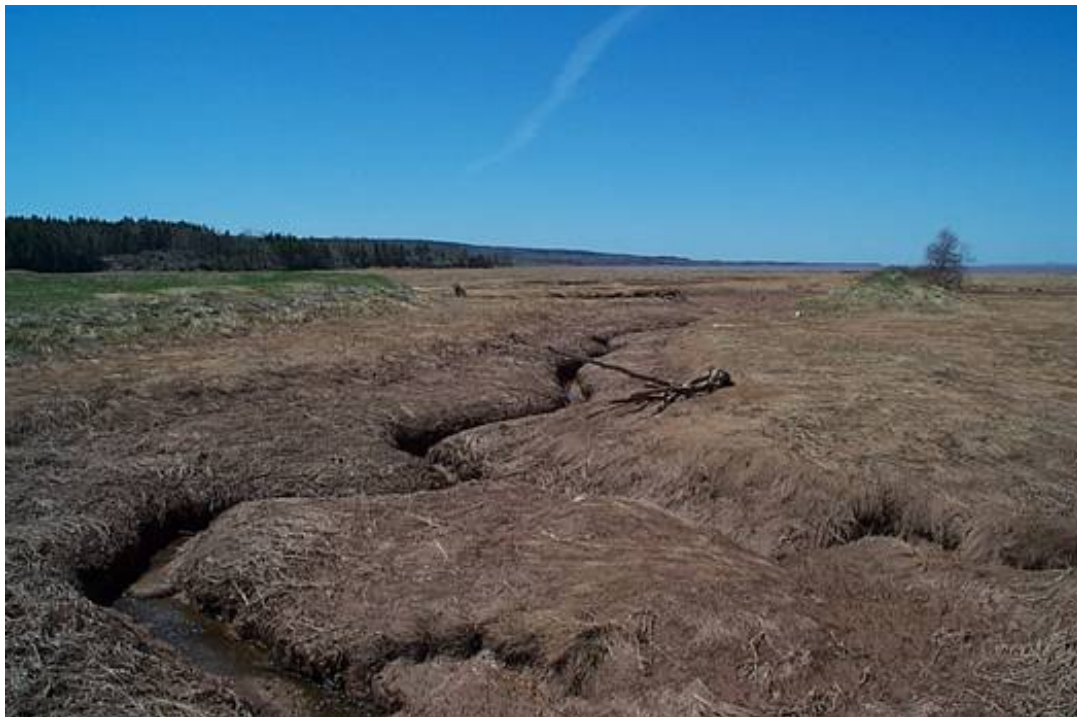
Figure 3. Downstream of crossing

Creek: Smooth, straight flow, bank slumping, scour pool
