Site N9C: Noel Marsh

Date Assessed: 08/05/01

Crossing Status: Complete restriction

Road Crossing: Culvert (wooden box), 2 chambers 1 ½ m each

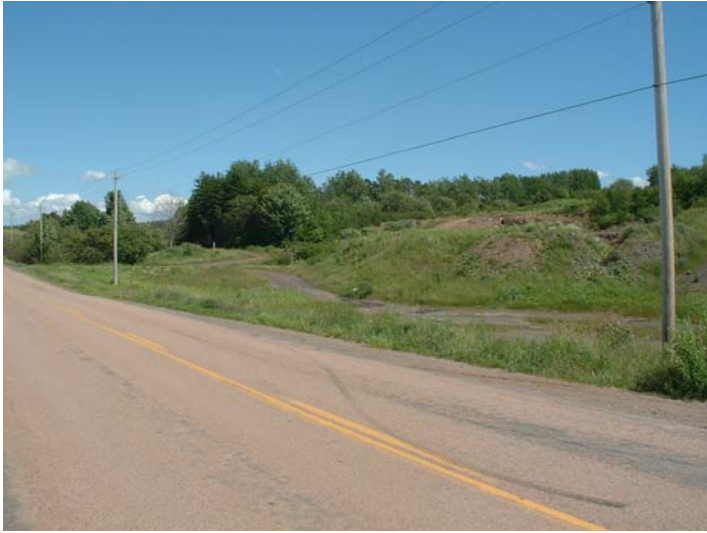
Figure 1. Upstream

Creek: Smooth, straight flow

Land: Freshwater creek, not in use

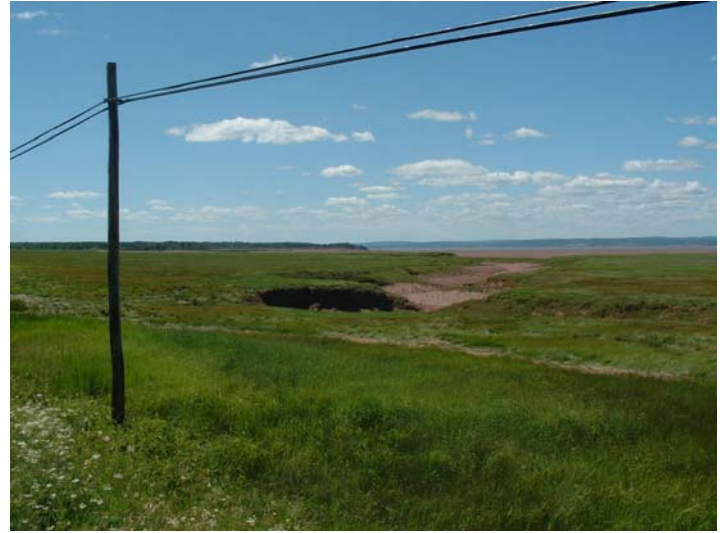
Figure 2. Downstream

Crossing Condition: Base tearing away slightly

Creek: 3m wide, bank slumping, scour pool, slack water

Land: Salt marsh, hay straddles

Comments: Base of culvert is above the high water line, culvert needs to be lowered to allow for tidal flow and fish passage.
