**Site HCMB 21:** Avon River**Date Assessed:** N/A**GPS Coordinates:** N 44° 59' 46.8"  
W 64° 08' 55.0"**Crossing Status:** Complete restriction**Road Crossing:**

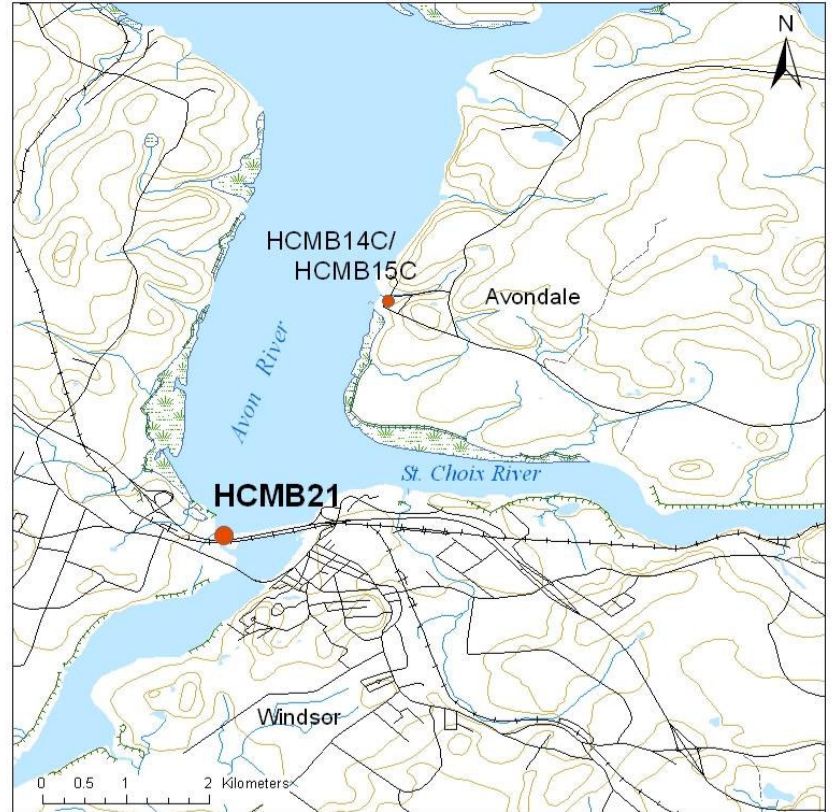
Causeway, approximately 1km wide with a tide gate operated to control upstream water level and limits fish passage. Salt water is not allowed in head pond.

- Differences in water levels
- Bank slumping
- Differences in stream width
- Turbulent water flow
- Vegetation differences
- Aboiteau/tide gate
- Scour pool
- Divergent channel
