**Site HCMB 6B:** Kennetcook River (Stanley)**Date Assessed:** 04/09/03,  
05/12/03**GPS Coordinates:** N 45° 05' 24.8''  
W 63° 56' 17.1''**Crossing Status:** No restriction.**Road Crossing:**

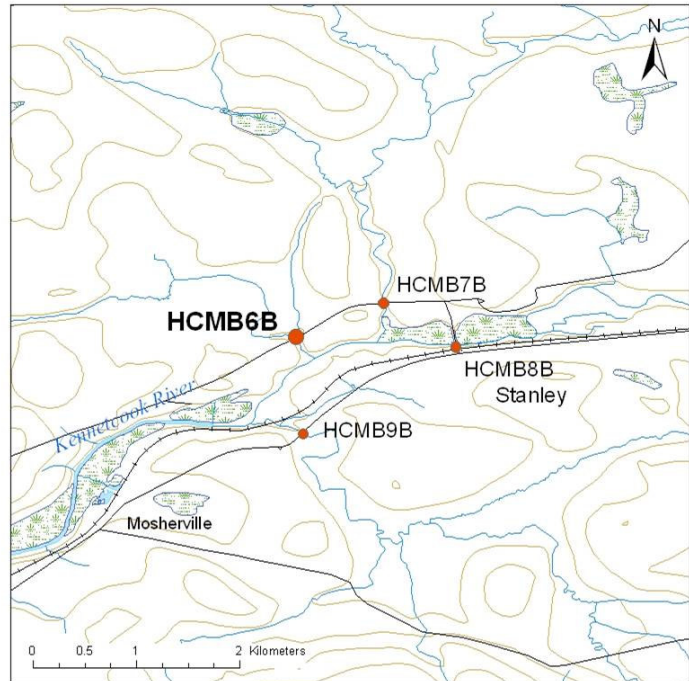
A 6m long wooden bridge with an opening width of 5m.

Structure is old but remains intact.

**Restriction Indicators:** None**Downstream of Crossing****Creek:** 4m in width with a smooth flow.**Land:** Salt marsh is on both sides of the creek. It was or is being grazed with no protection along the banks of the creek.

**Upstream of Crossing****Creek:** 4m in width with a smooth flow.**Land:** Salt marsh is on both sides of the creek.**Comments:** When repair or replacement is needed, the structure should remain a bridge with an opening width no smaller than 5m.

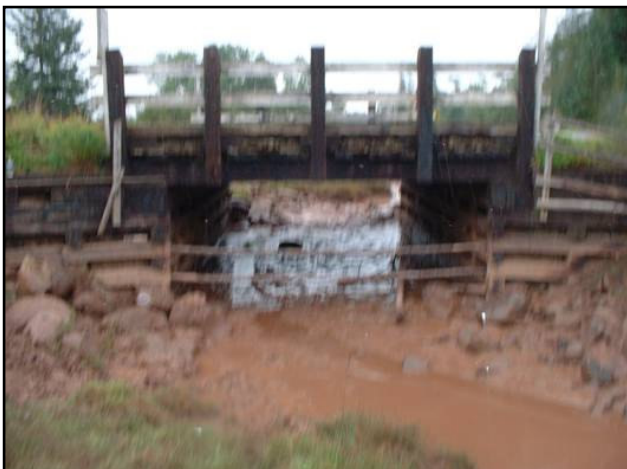
**Figure 1:** A fence built across the creek under the bridge keeps grazing animals from going to the other side, but the banks of the creek are not protected.

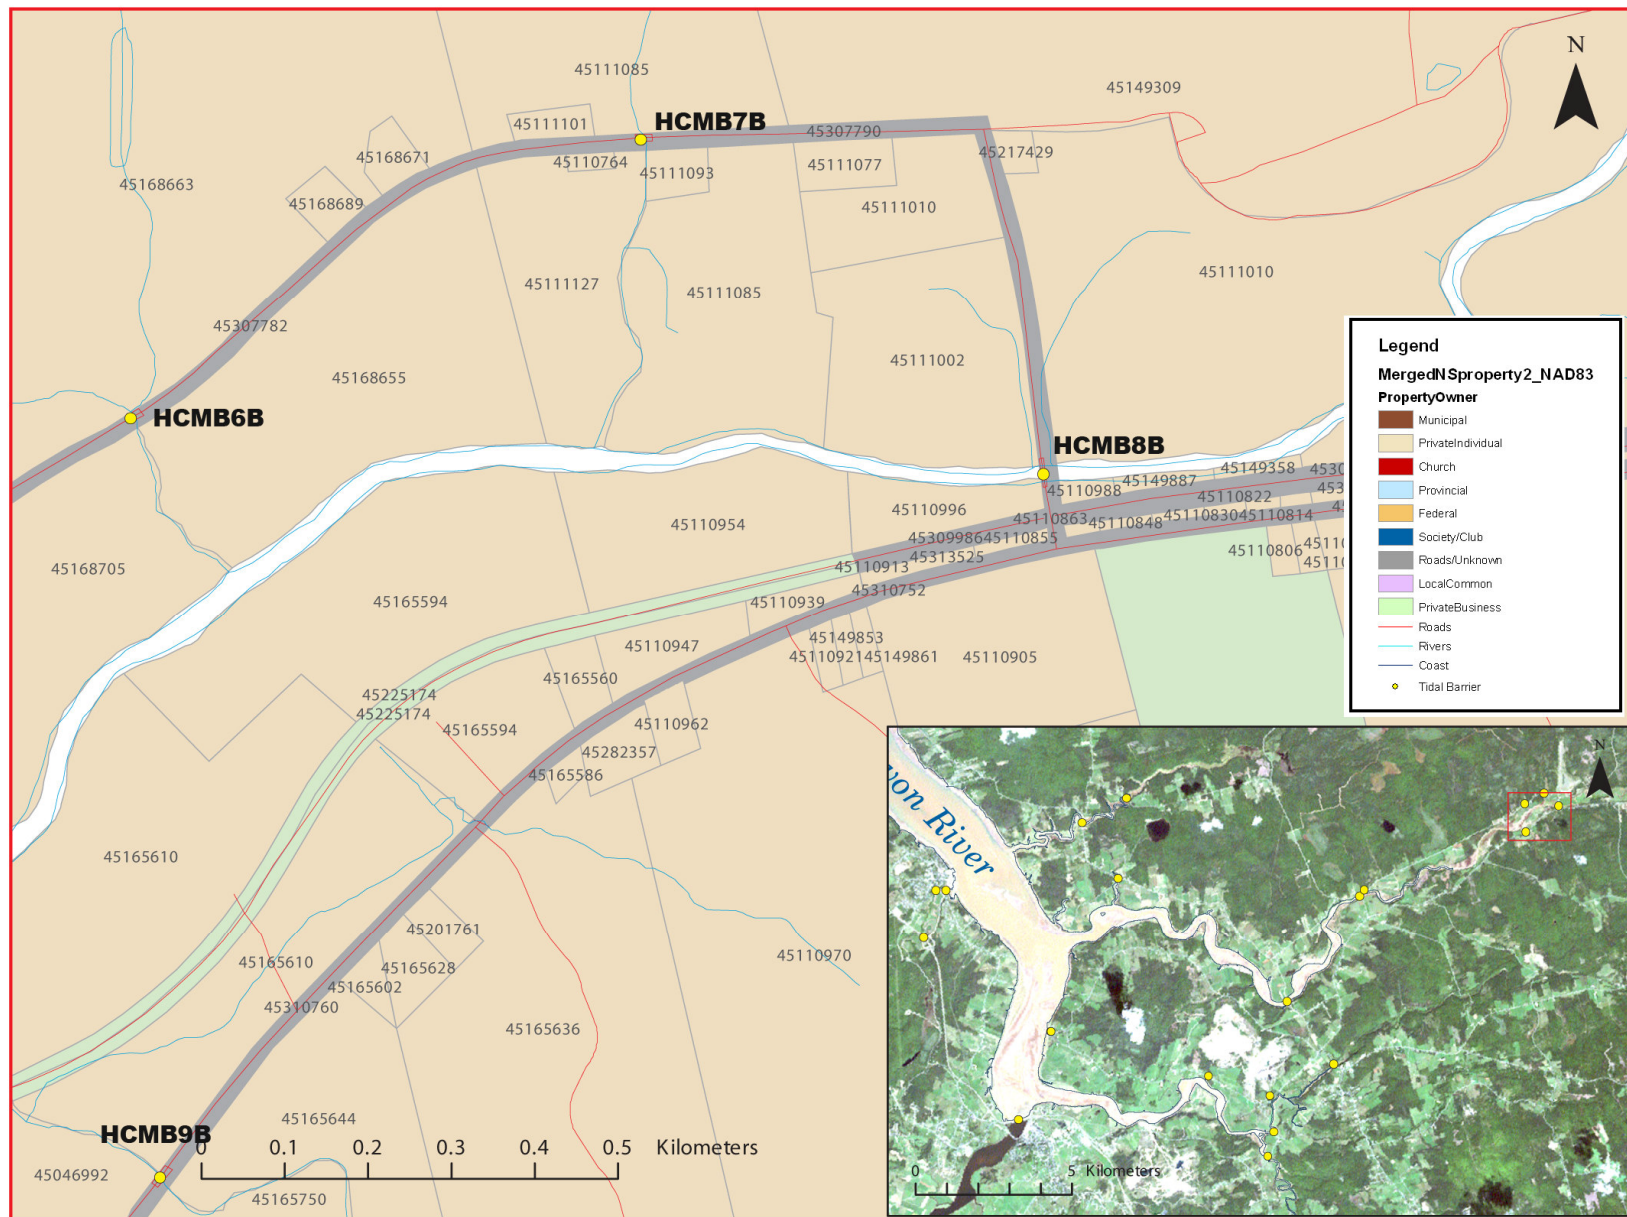
**Figure 2:** Property management and tidal barrier data for Nova Scotia (Service Nova Scotia, and Municipal Relations)

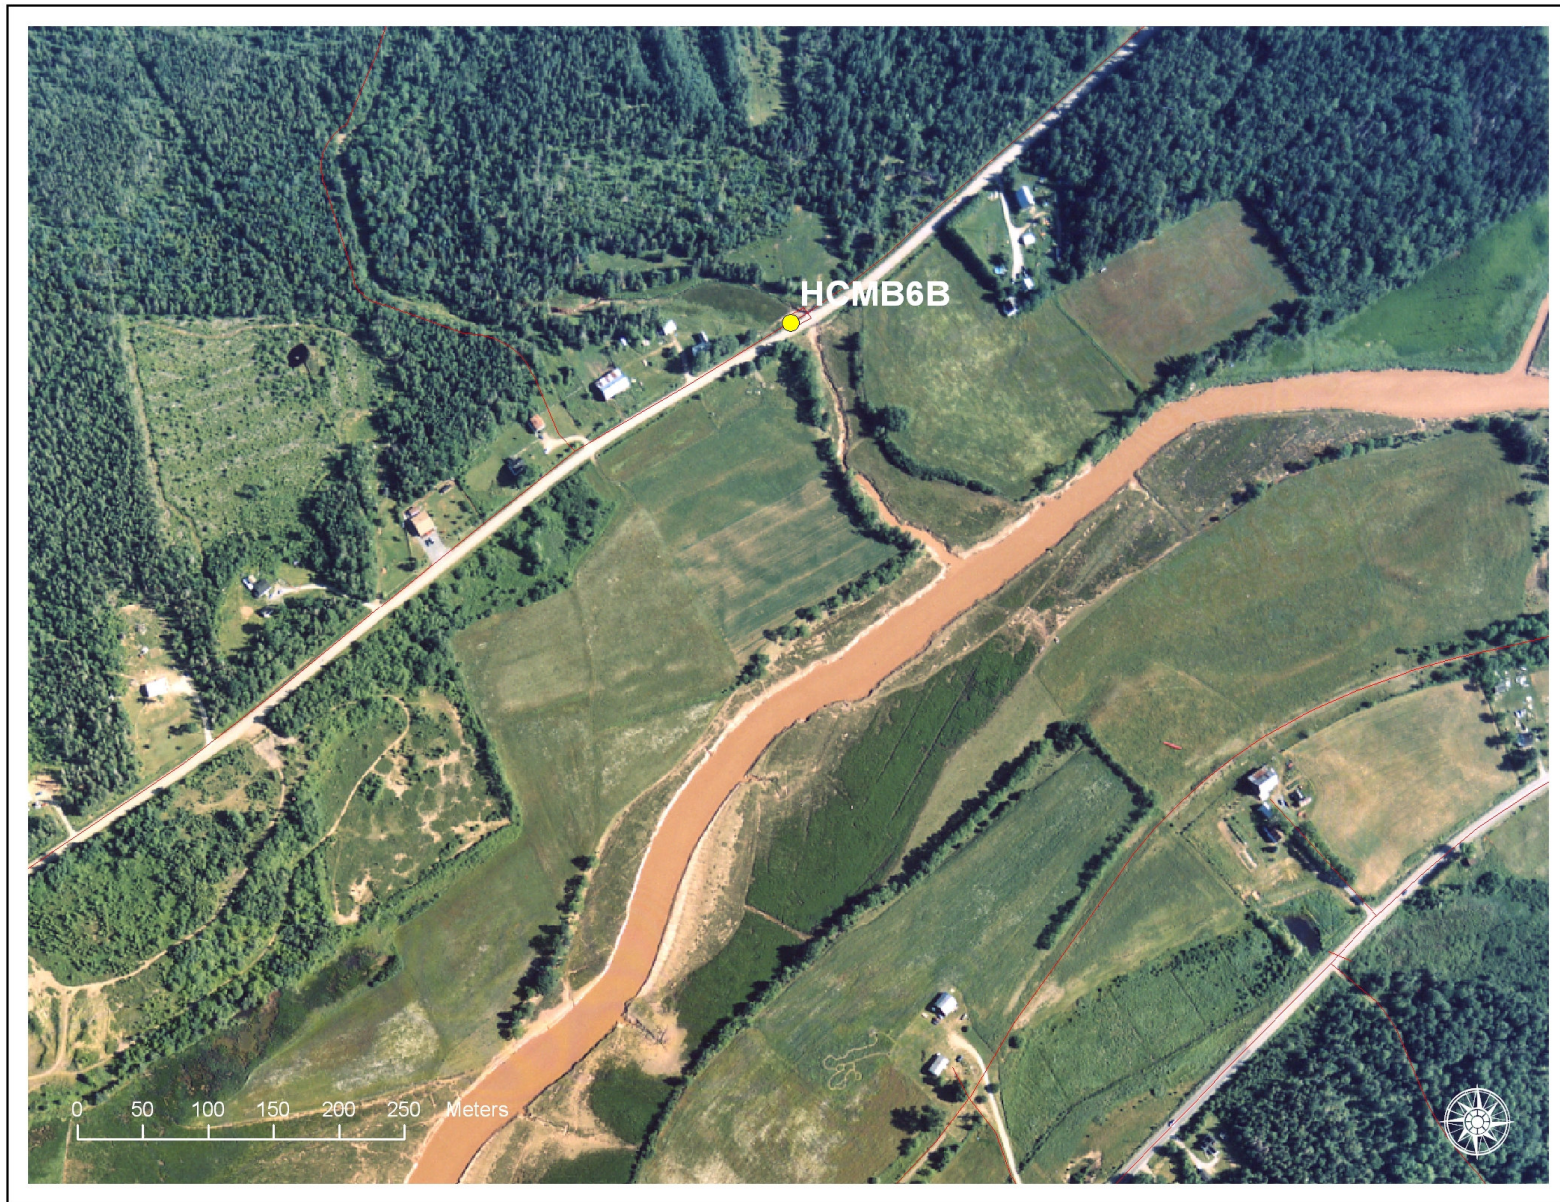
**Figure 3:** 2002 Aerial photograph containing tidal barrier data, (1: 10,000)
