Site HCMB 7B: Kennetcook River (Stanley)

Date Assessed: 04/09/03,
05/12/03

Road Crossing: A 14m long wooden bridge with an opening width of 10m.

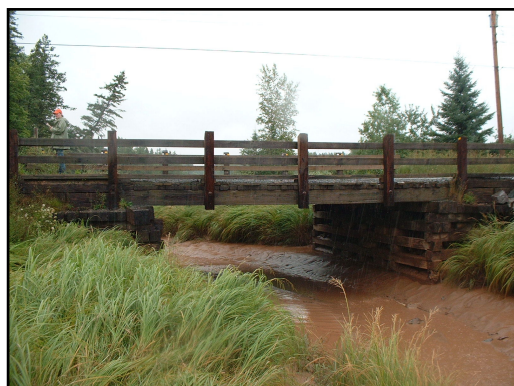
Figure 1: Downstream of bridge. Wooden support structures are on the upper banks of the creek.

Comments: When repair or replacement is necessary, structure should remain a bridge with an opening at least the same size as currently present.

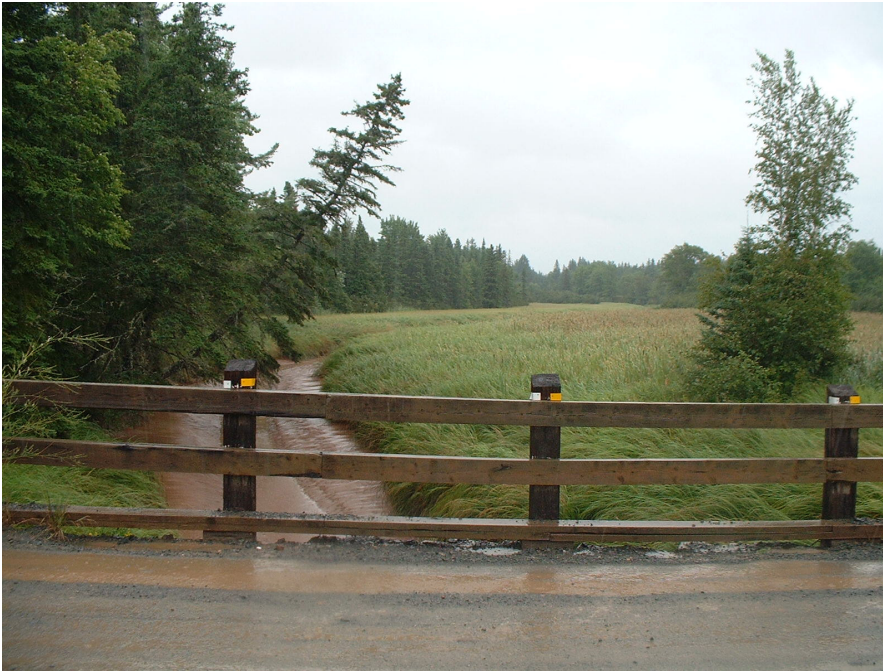
Figure 2: *Upstream of the bridge there is tidal mud in the creek and trees growing quite close to it.*

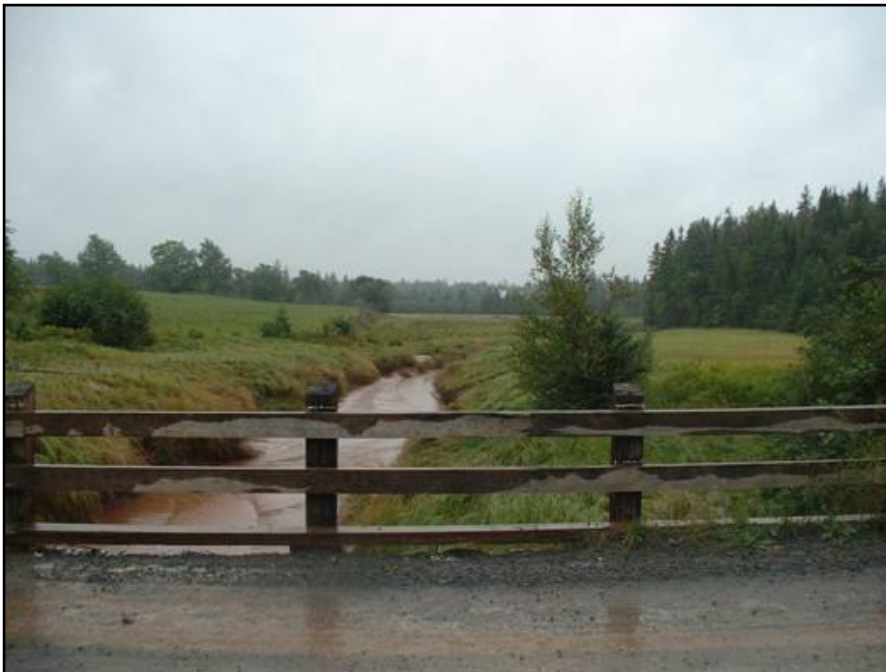
Figure 3: *Downstream of the bridge shows steep creek banks and tree growth. Salt vegetation is evident very near the creek.*
