Site HCMB 8B: Kennetcook River (Stanley)

Date Assessed: 04/09/03,
05/12/03

Road Crossing: A 22m long steel bridge with an opening width of 14m.

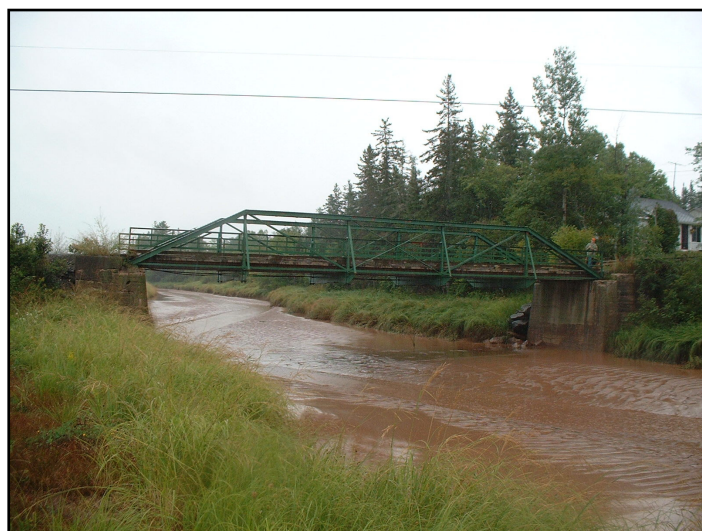
Figure 1: Downstream of the bridge shows the elevation rise on one side of the river with trees and a house. The other side of the river is where the animals graze.

Comments: When repair or replacement is necessary, the structure should remain a bridge with an opening of at least the same dimensions there now.
