Site KCMB 12A: Canning Aboiteau – Habitant Creek

Date Assessed: 03/08/04

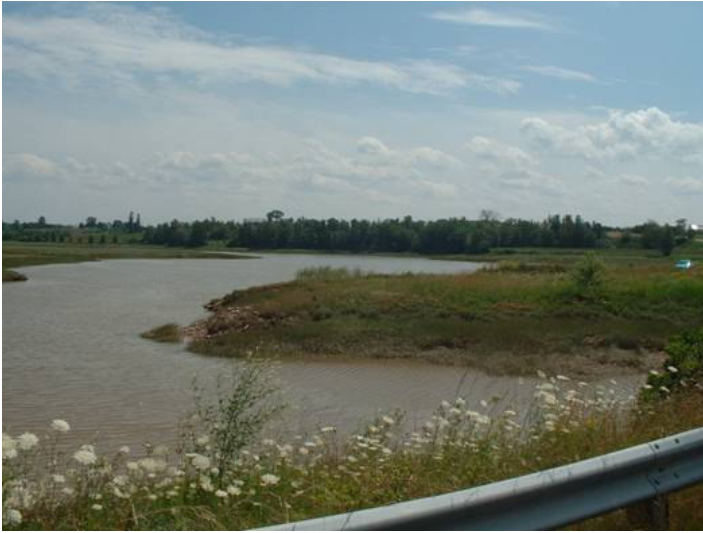
Creek: Mouth of the Habitant Creek with 30m stream width at aboiteau.

Land: Salt marsh

Figure 1. Downstream of aboiteau, large salt marsh

Comments: Land upstream is a mix of fallow and actively farmed agricultural land. As restoration of tidal flow and salt marsh habitat is unlikely at this site, accommodations for fish passage should be explored

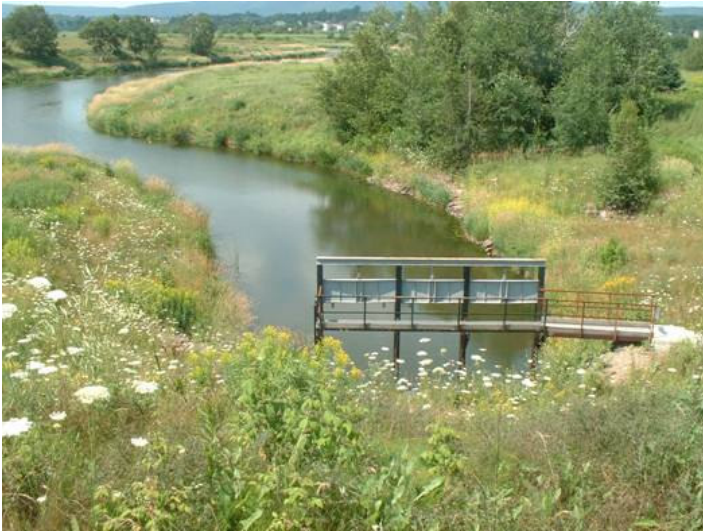
Creek: 5m stream, smooth flow, freshwater

Land: Agricultural dykeland, additional crossings upstream but no longer tidal and therefore not assessed.

Figure 2. Upstream end of aboiteaux and upland area.

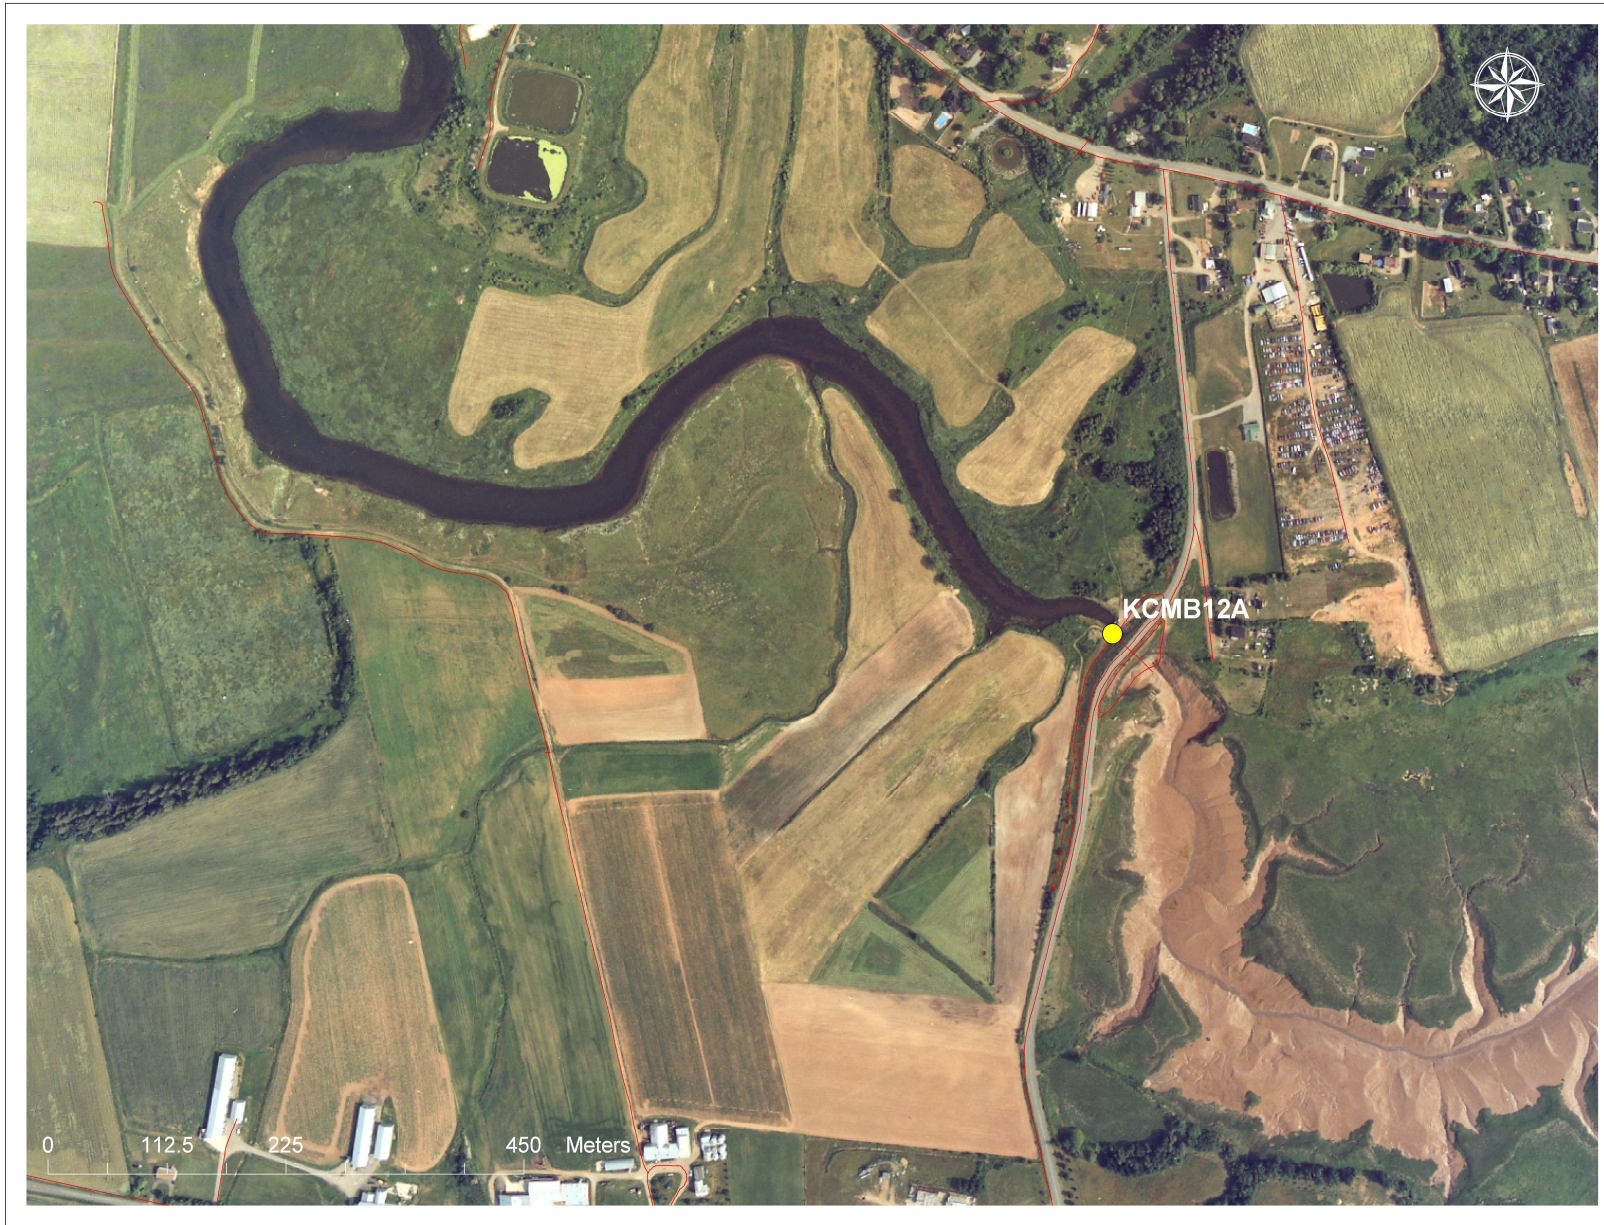
Figure 4: 2002
Aerial photograph
containing tidal
barrier data,
(1: 10,000)
