Site KCMB 1C: Avonport Station

Date Assessed: 04/09/03, 05/12/03

Crossing Status: Partial restriction.

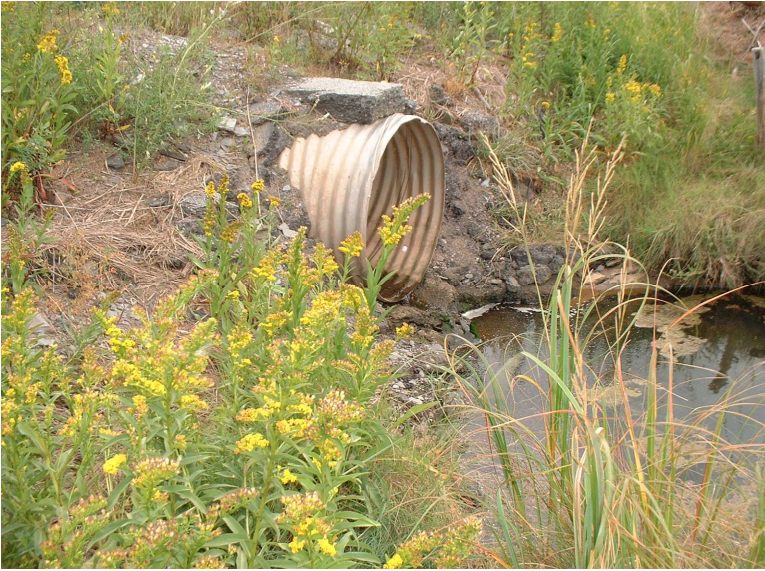
Restriction Indicators:
Vegetation differences
Slack water
Scour pool
Hanging culvert

Creek: 0.5m wide creek, small wetland.

Land: Small area of tidal/freshwater marsh with quick rise in elevation to upland agricultural land.

Figure 1. Upstream of culvert.

Comments: Road built along upland edge of large tidal marsh that appears to be in use as agricultural grazing land. Culvert drains small wetland upstream of road (and upland agricultural area). A larger culvert, set flush with the creek bed would improve tidal exchange and drainage of upland but crossing is low priority.

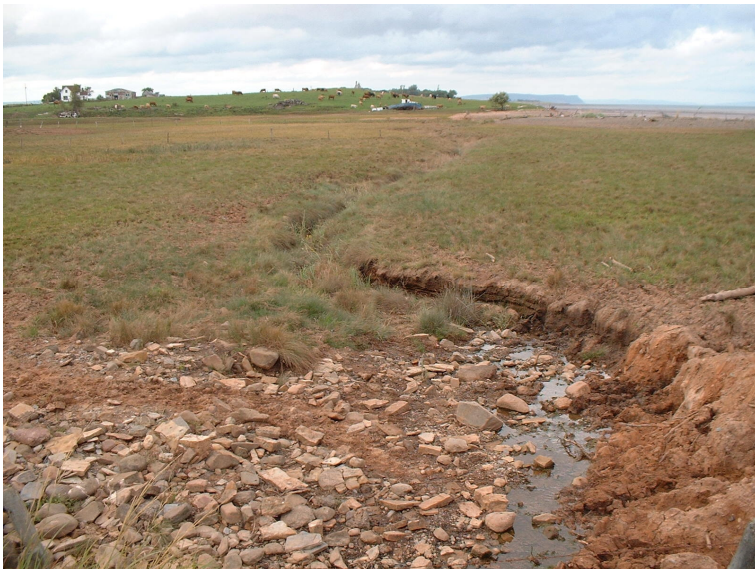
Creek: Small drainage creek winding through tidal marsh.

Land: agricultural marshland – apparently used for cattle and grazing.

Figure 2. Downstream of culvert.

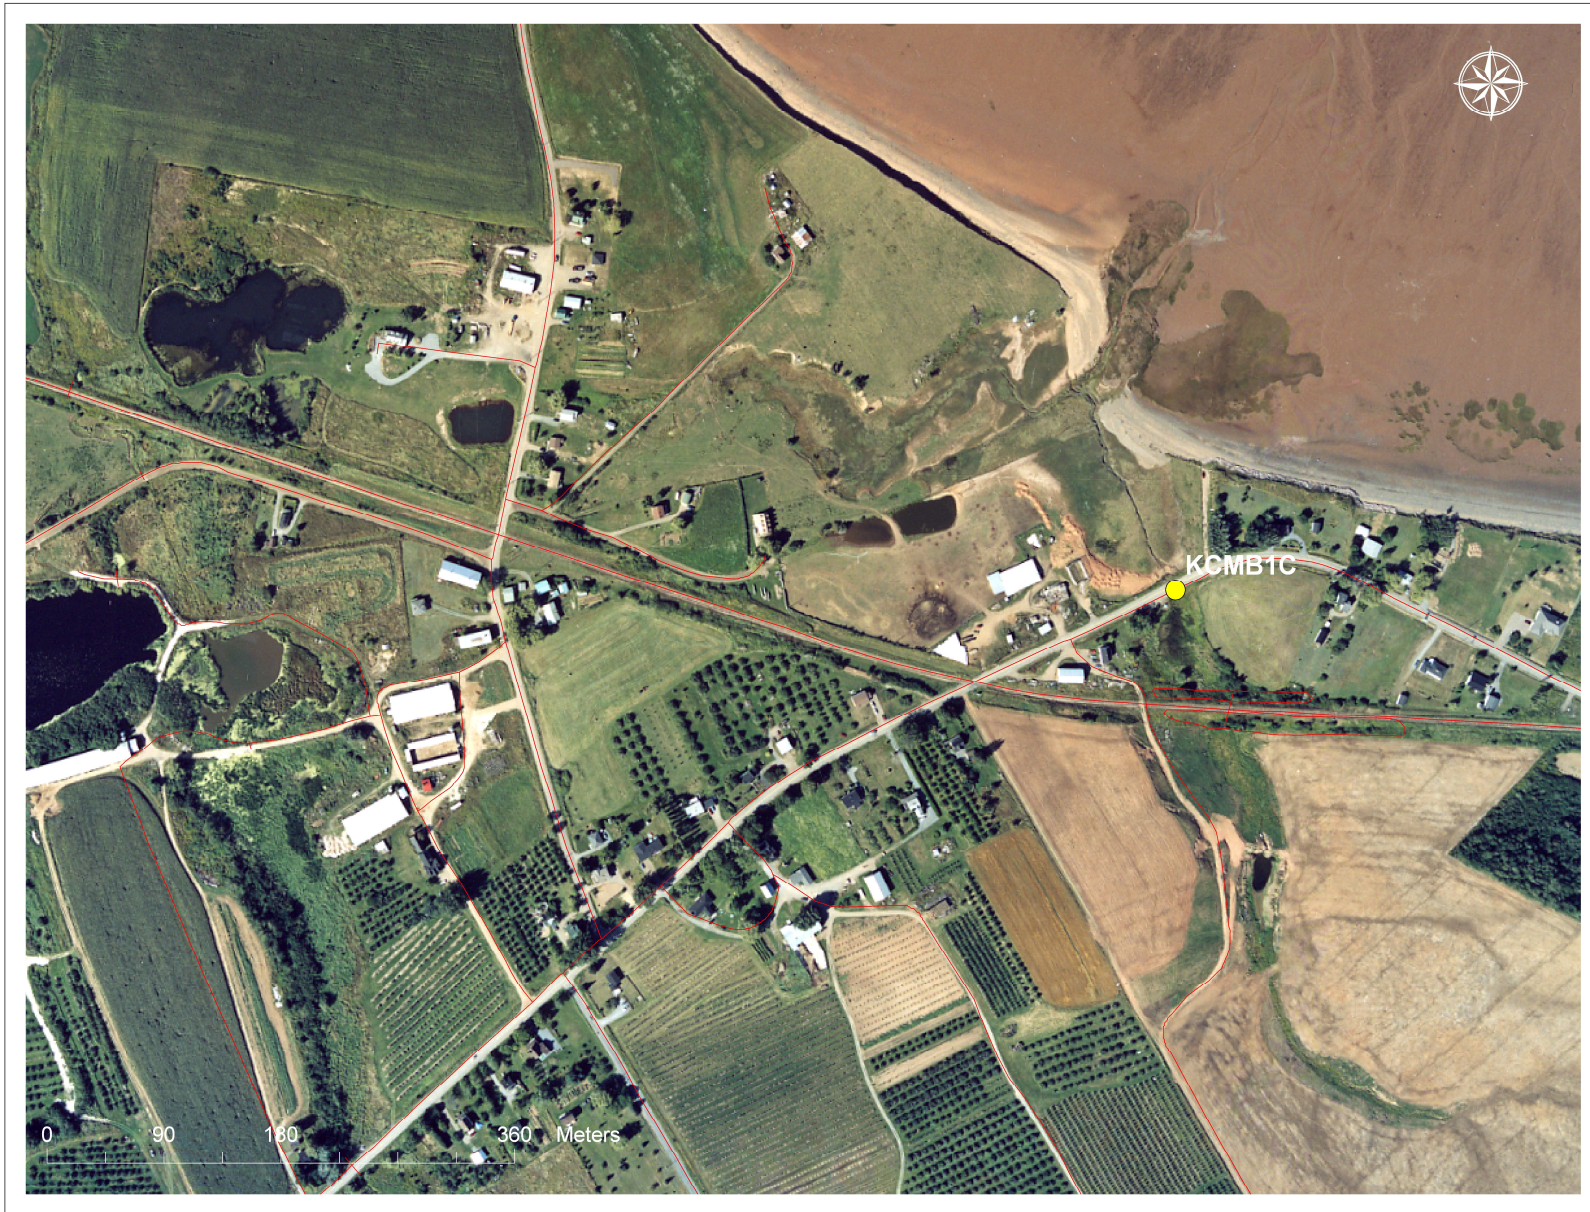
Figure 4:
2002 Aerial
photograph
containing
tidal barrier
data,
(1: 10,000)
