Site KCMB 20C: Blomidon

Date Assessed: 03/08/04

Road Crossing: Wooden box culvert

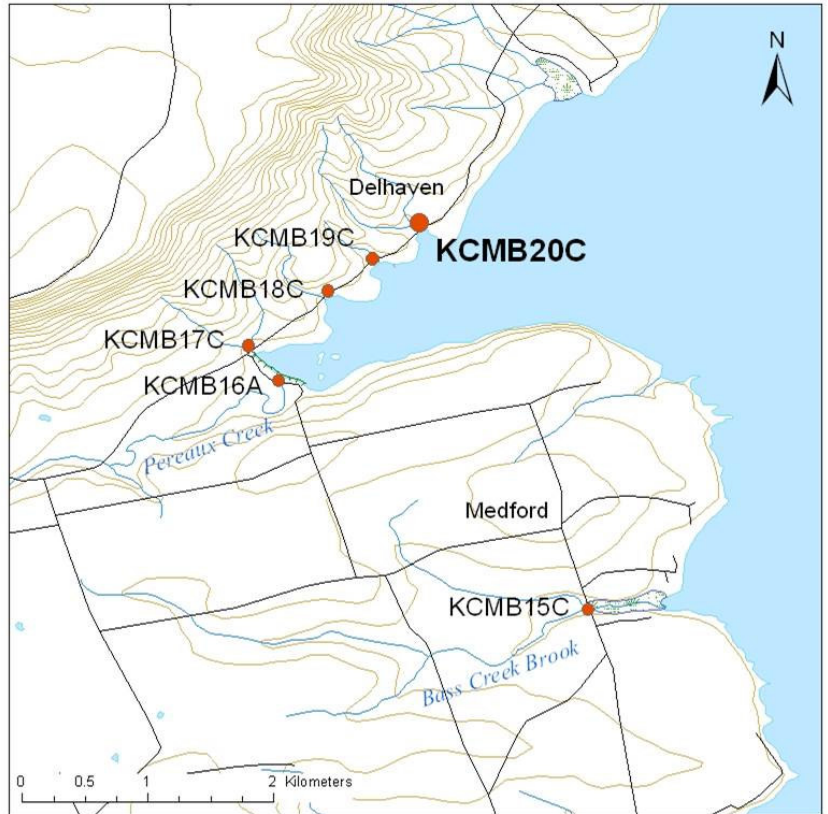
Crossing Condition: Intact

Restriction Indicators:

- Difference in water levels
- Difference in stream width
- Scour pool
- Bank slumping

Comments: Little restoration potential, small marsh upstream with little room to expand.

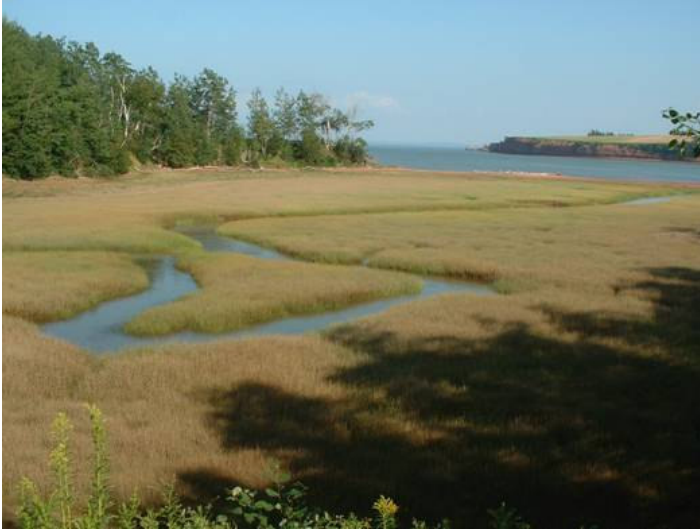
Figure 1. Downstream of crossing

Downstream of Crossing

Creek: 2m wide opening into Pereaux Creek estuary.

Land: Salt marsh and forest.

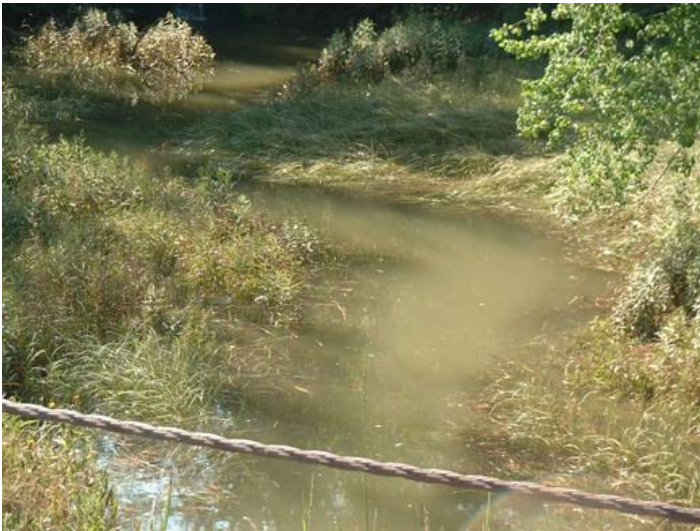
Figure 2. Upstream of crossing

Upstream of Crossing

Creek: Smooth straight flow, 2m width.

Land: Small wetland and forest.

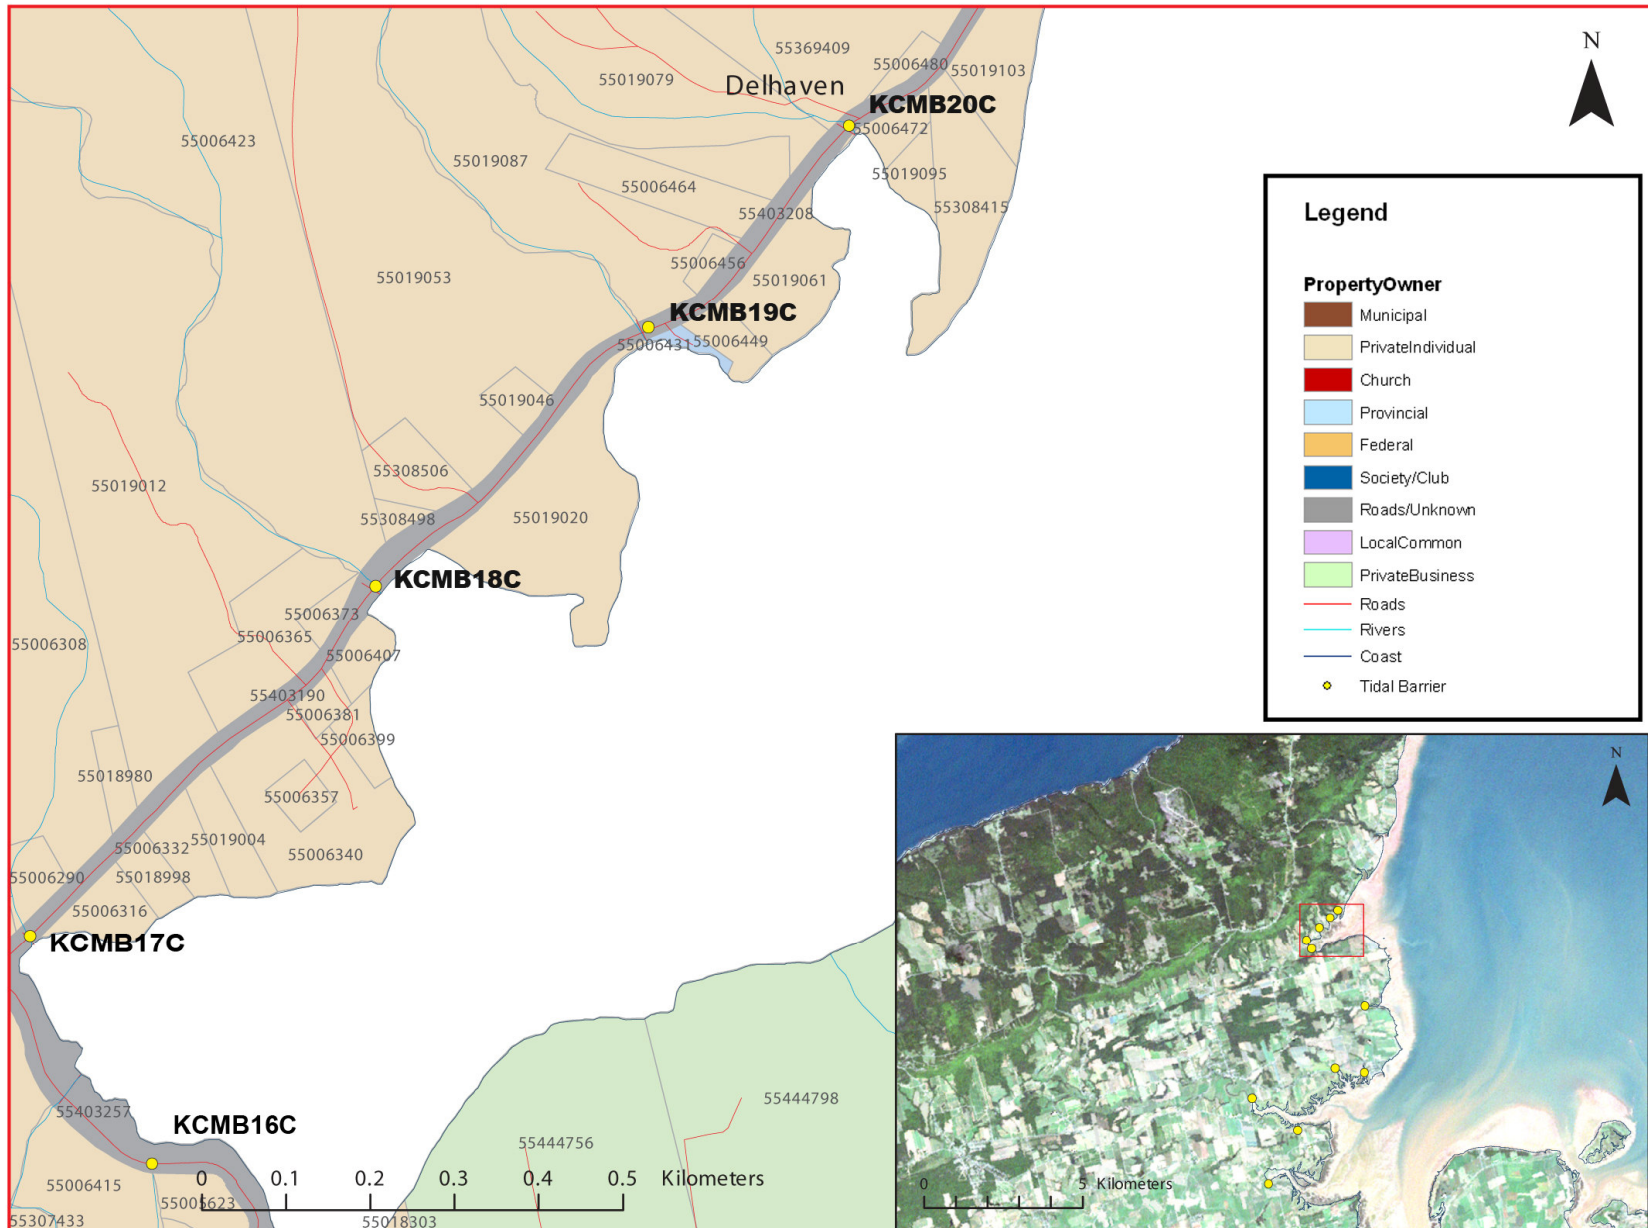
Figure 3: Property management and tidal barrier data for Nova Scotia (Service Nova Scotia, and Municipal Relations)

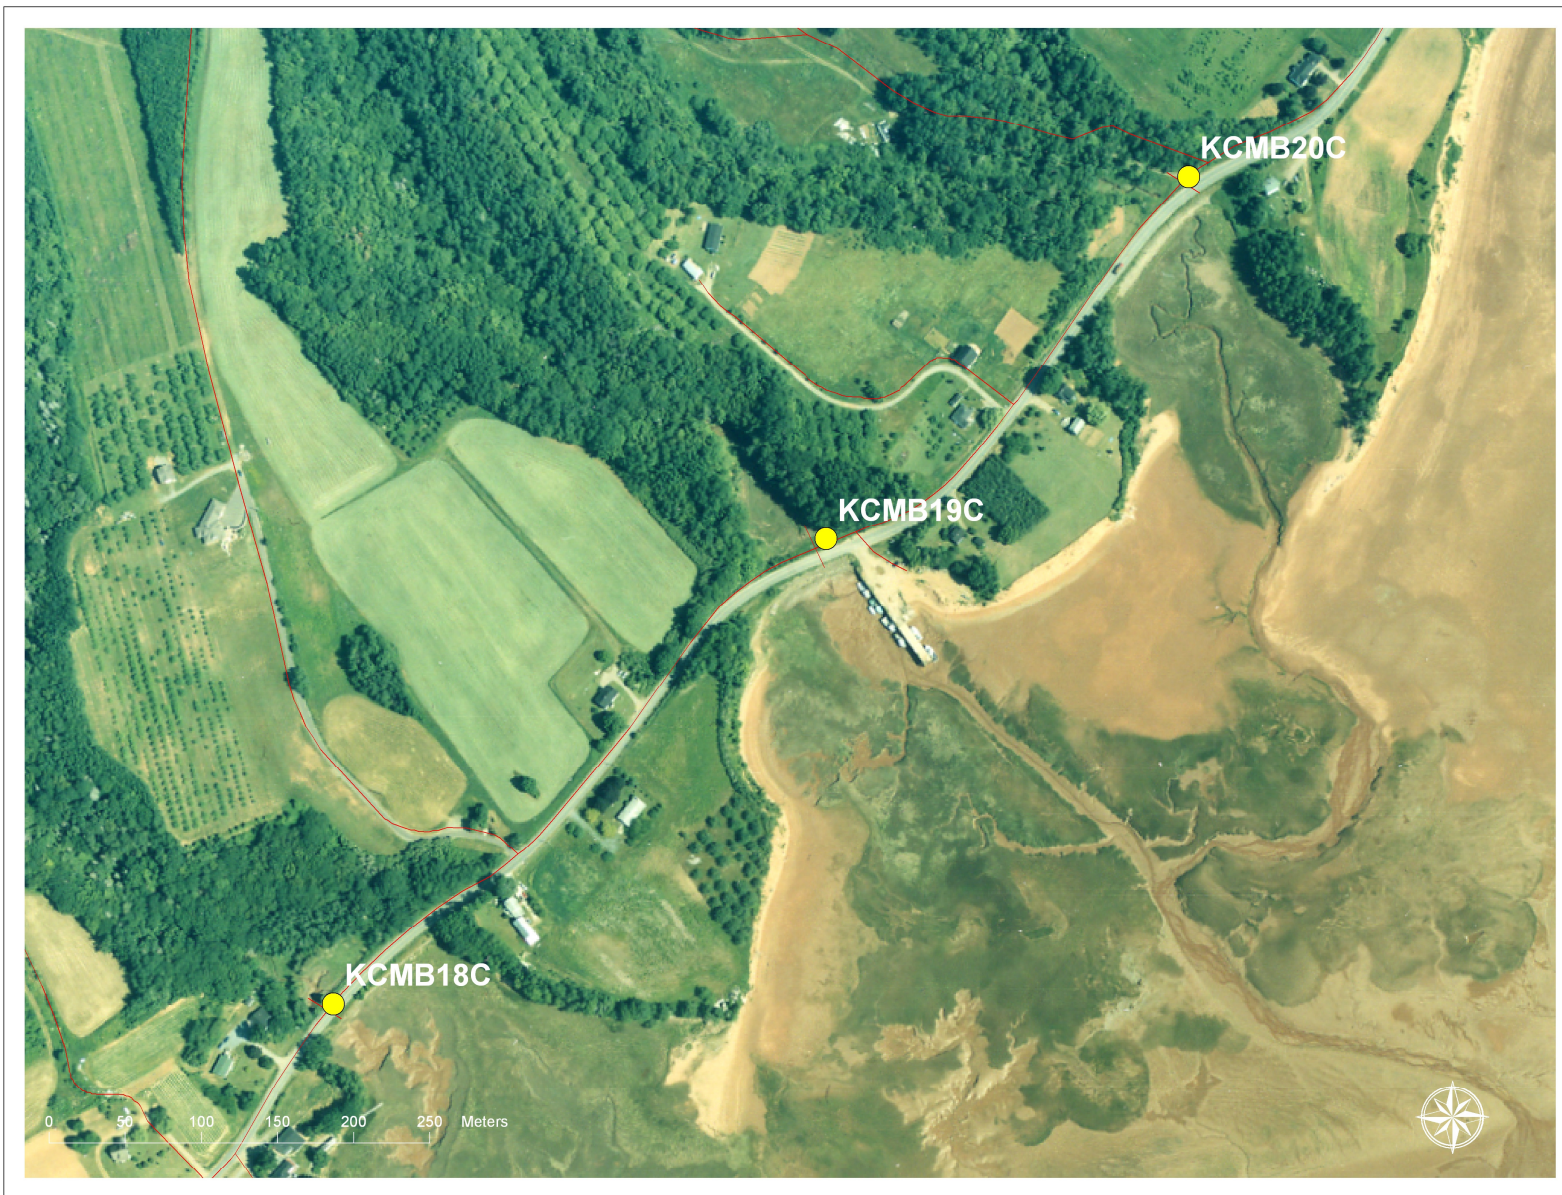
Figure 4: 2002 Aerial photograph containing tidal barrier data, (1: 10,000)
