Site KCMB 8B: Kentville

Date Assessed: 03/08/04

Road Crossing: Steel bridge crossing the Cornwallis River within the town of Kentville.

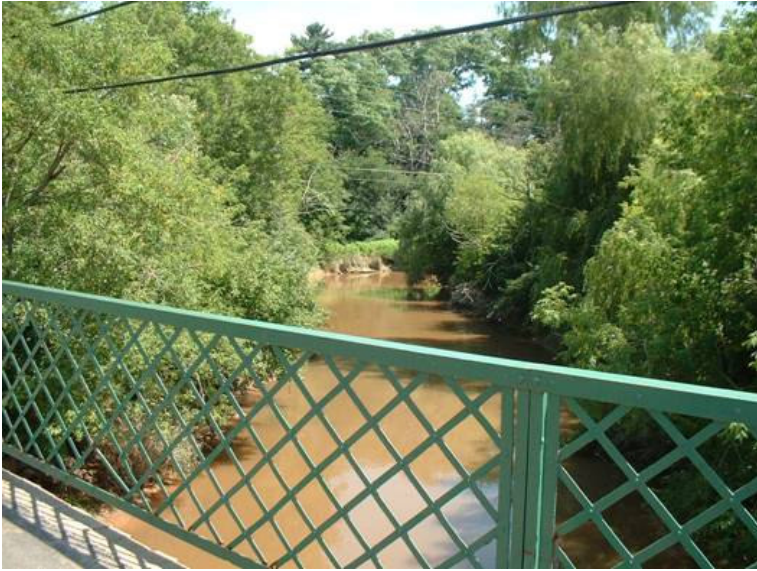
Creek: Smooth, straight flow

Land: River edge is forested but adjacent lands dominated by development (Town of Kentville).

Figure 1. Downstream of crossing, forested.

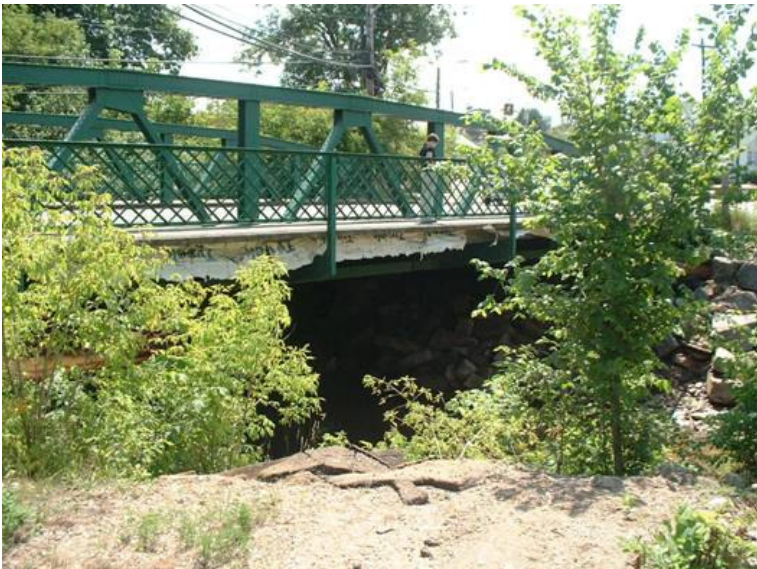
Crossing Condition: Intact

Comments: Bridge does not impact hydrology and crosses river near the upper reaches of tidal influence. Crossing size should be maintained when repair/replacement is required.

Figure 2. Crossing view from upstream

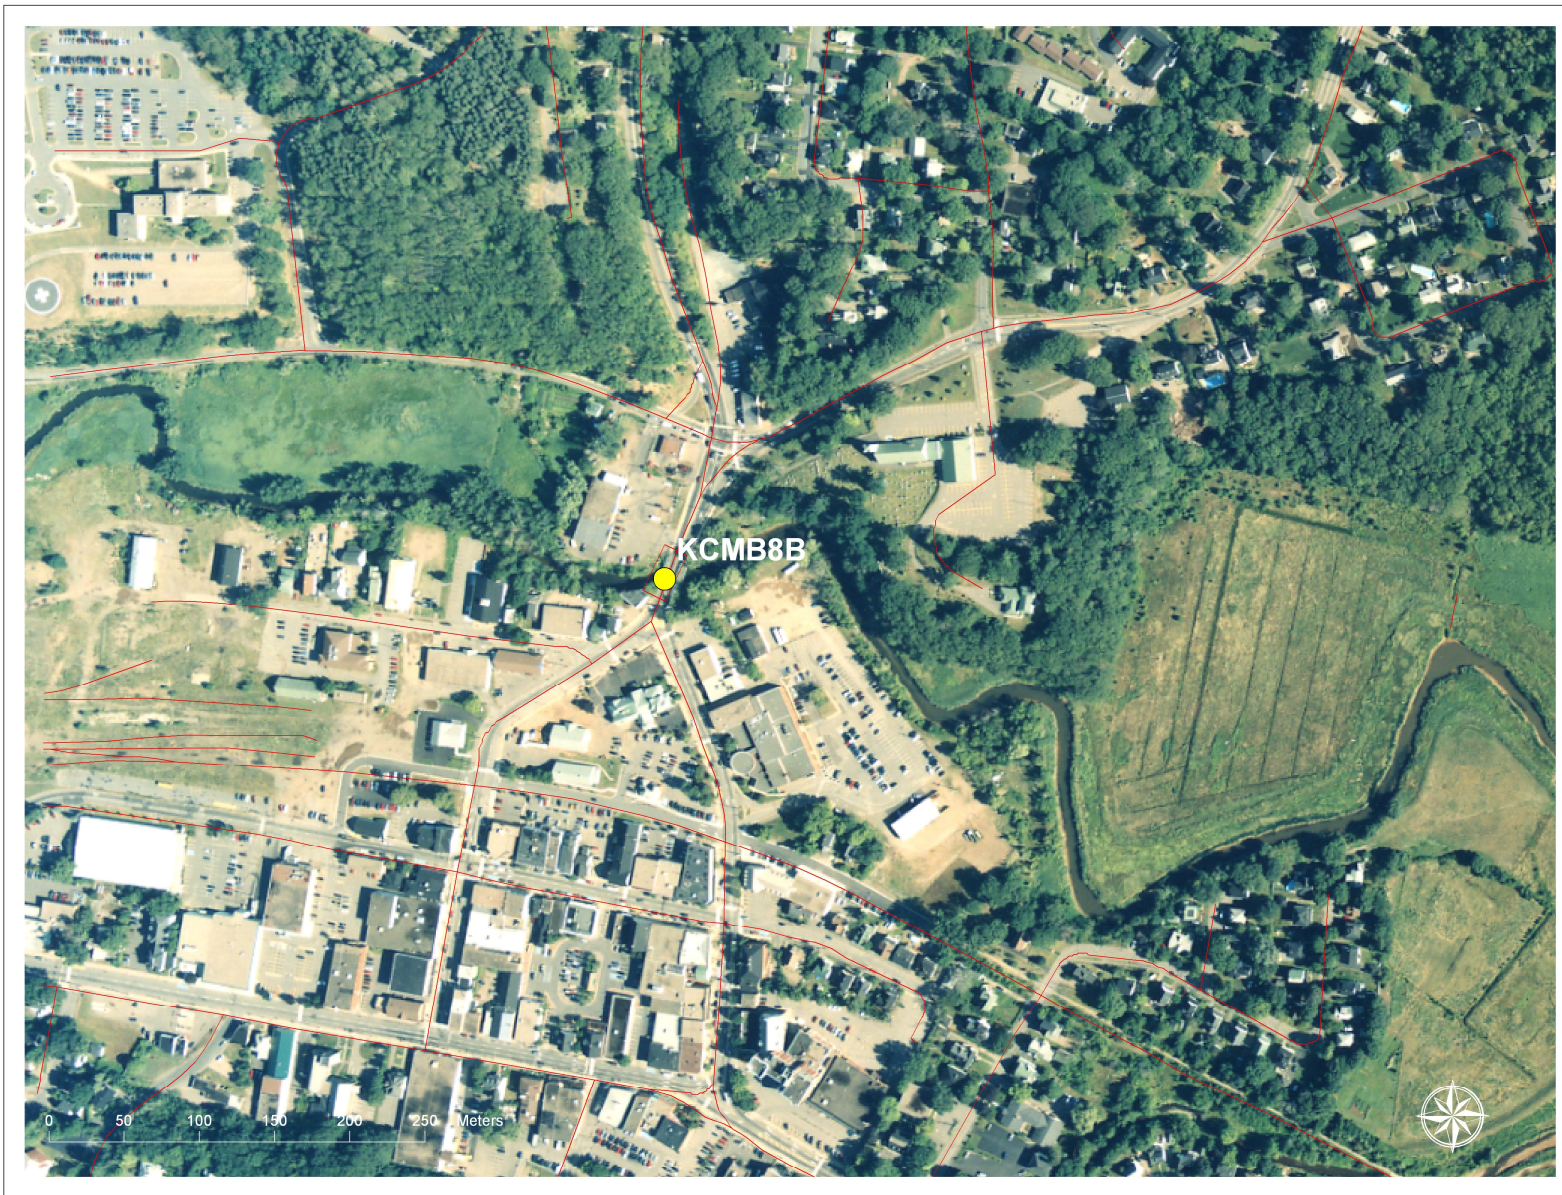
Figure 4: 2002 Aerial photograph containing tidal barrier data, (1: 10,000)
