Site KCMB 9B: Cornwallis River (Port Williams)

Date Assessed: 03/08/04

Road Crossing: 130m steel bridge crossing Cornwallis River.

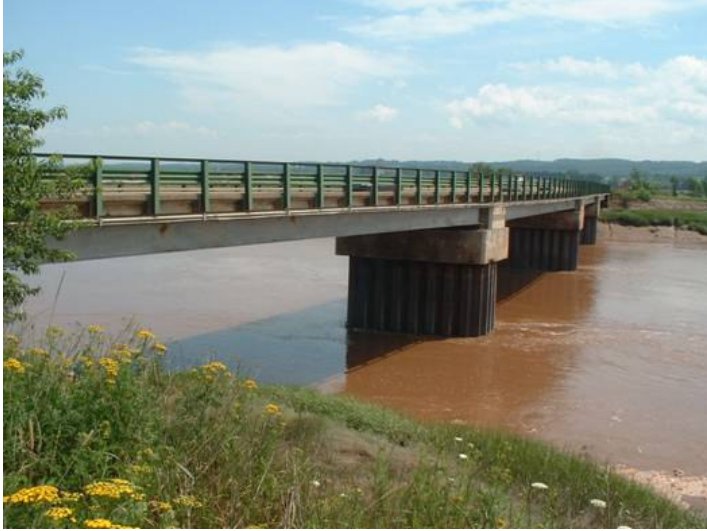
Crossing Condition: Intact with three large support structures in river channel.

Comments: Large bridge spanning main river channel which has little impact on tidal flow. Due to the size of the river channel, the three bridge supports likely have little impact on hydrology.

Figure 1. Cornwallis River bridge in Port Williams.

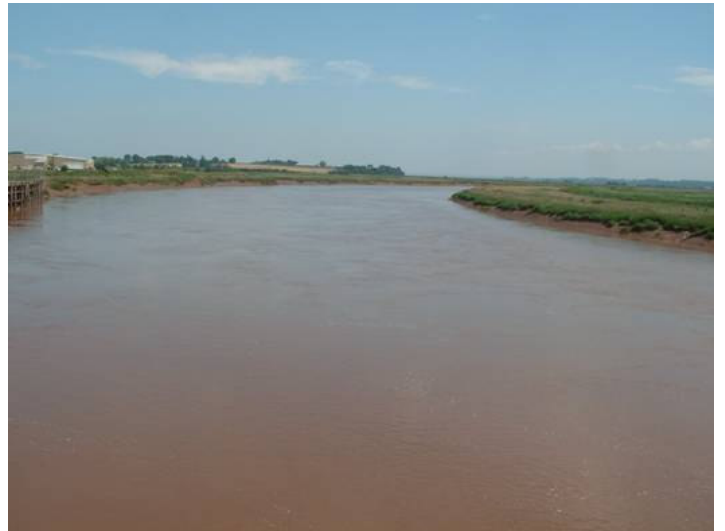
Creek: 120m wide, smooth flow except at base of bridge support structures

Land: Agricultural dykeland and fringe marsh.

Figure 2. Downstream of crossing

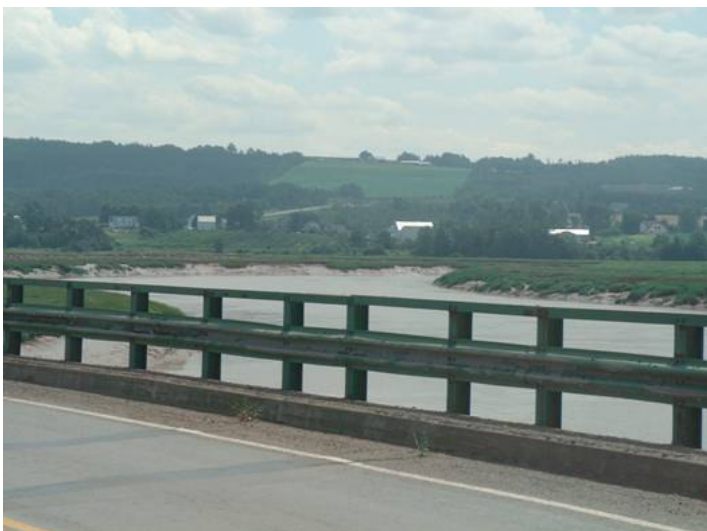
Creek: 120m wide river, smooth flow except at base of bridge support structures

Land: Agricultural dykeland and fringe marsh.

Figure 3. Upstream of crossing

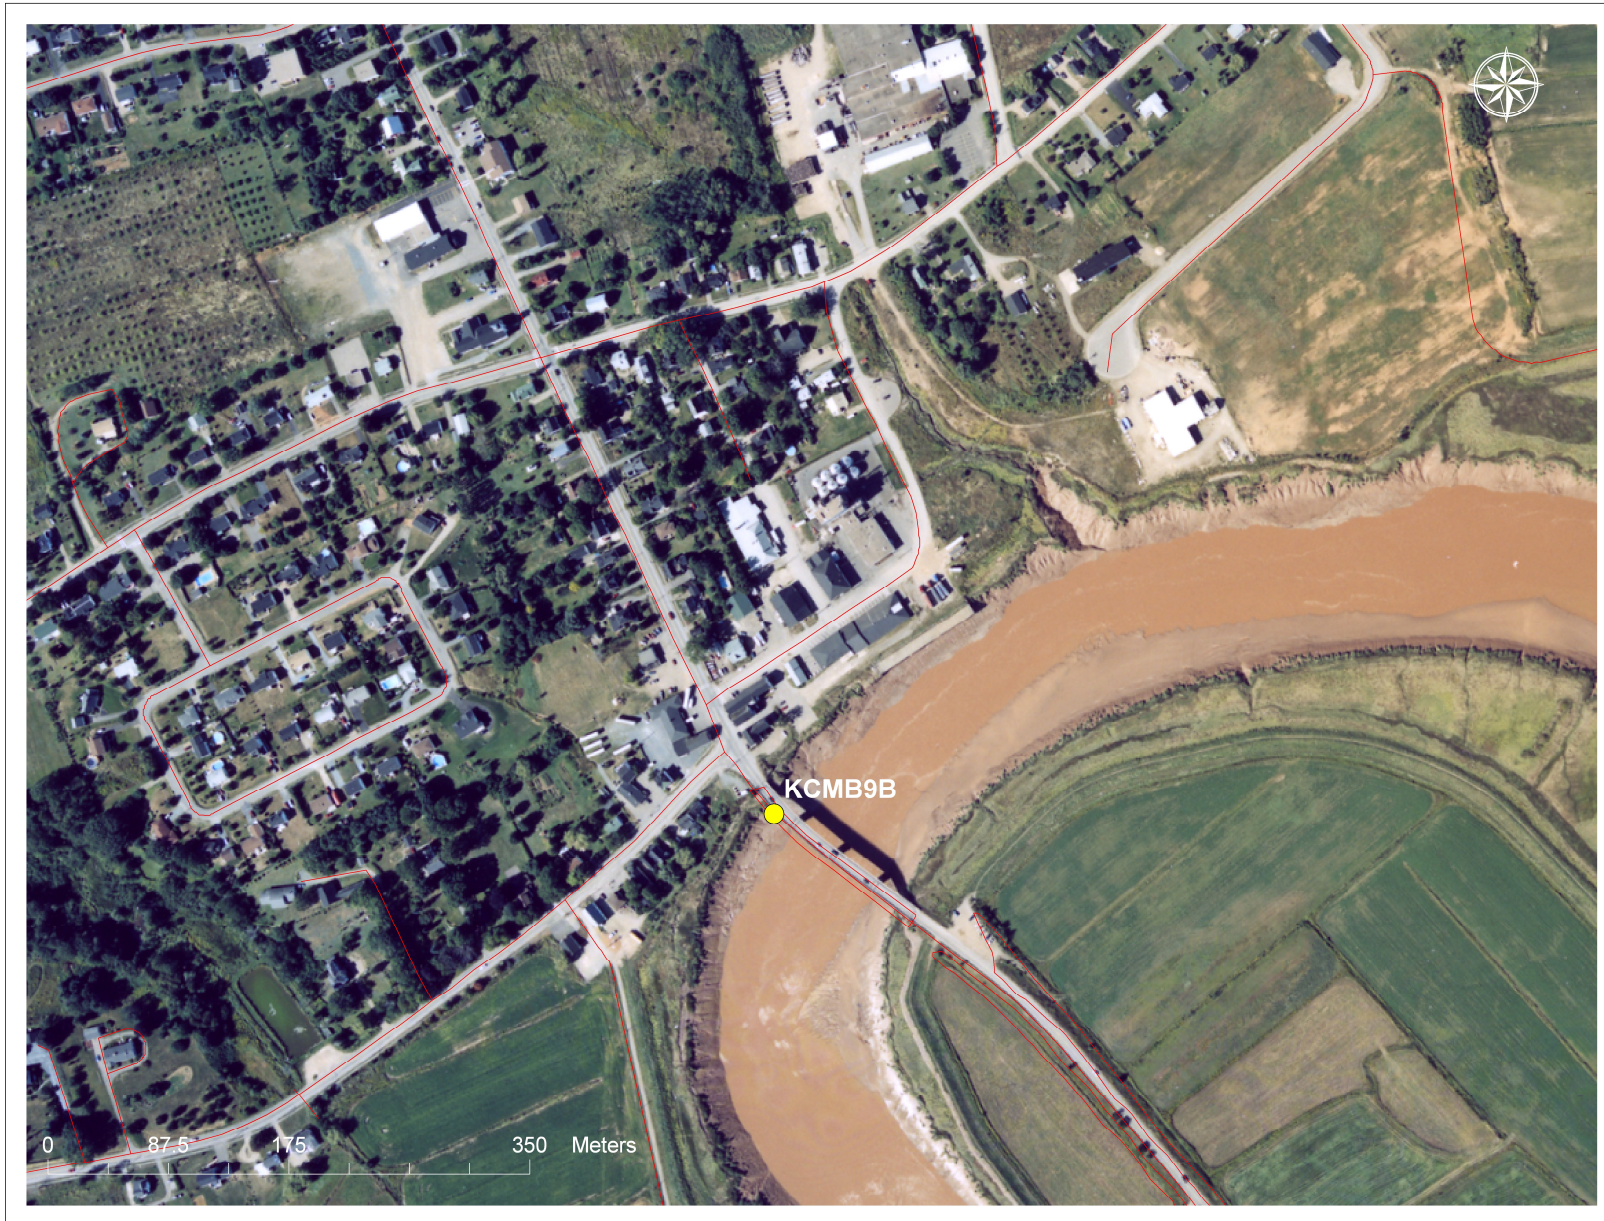
Figure 5: 2002
Aerial photograph
containing tidal
barrier data,
(1: 10,000)
