# FUNDY ISSUES

## The "Cause" in Causeway:

### Crossing the Avon River at Windsor

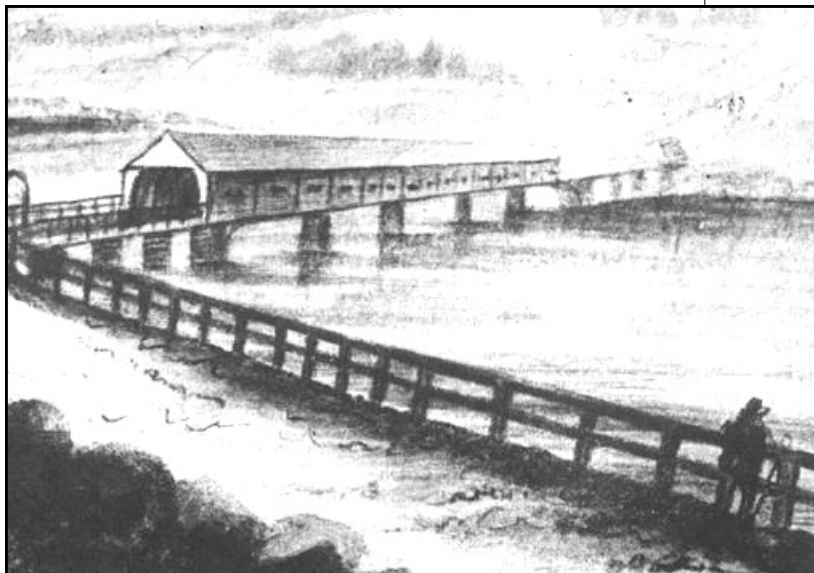
*The first bridge across the Avon at Windsor*

Gateway to the Valley". The pioneering wooden structure burned down not long after the first steel road bridge spanned the river in 1882. This was in turn replaced by the existing road bridge in 1982.

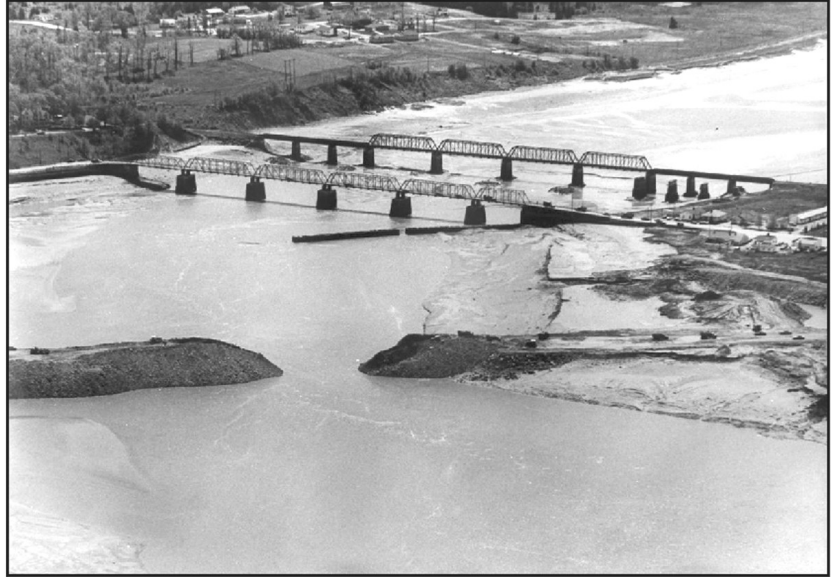
***By January 1969, only a narrow gap remained.***

Construction of the causeway across the Avon River at Windsor began in the fall of 1968, with the dumping of rock fill occurring from both sides of the river. By January 1970, only a narrow gap remained. A control structure with two large gates was installed and the remaining gap closed in the summer of 1970. The roadway was

opened for traffic later that autumn. The 700 metres (2,300 feet) long structure required 1.65 million tonnes of rock fill.
