Site CBNS17C: Shad Brook

Date Assessed: 11/07/02

Crossing Status: Partial Restriction

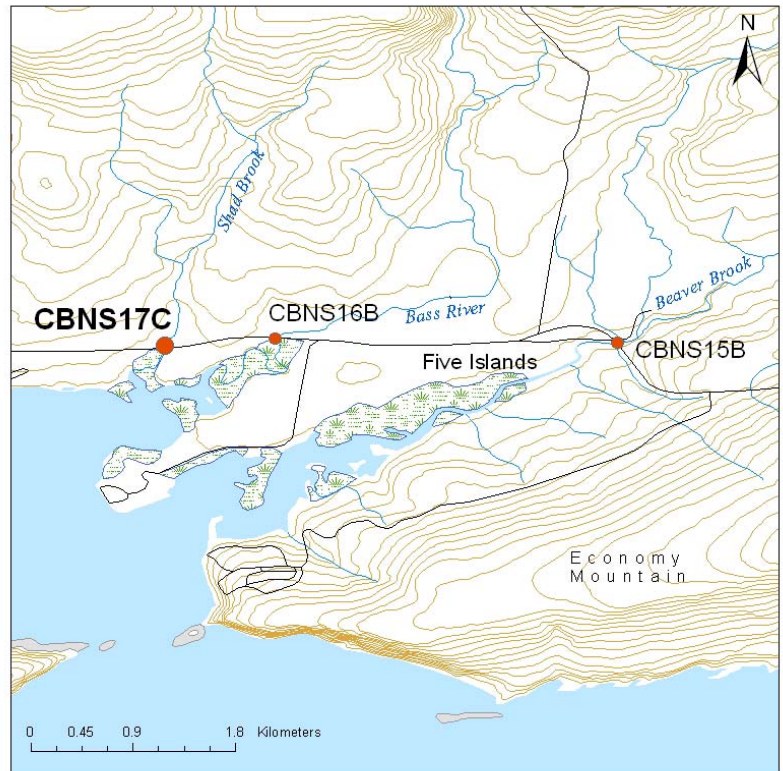
Road Crossing: Culvert (2 openings)
wooden box, 1.73m opening

Crossing Condition: In need of repairs,
division between openings is caving to one
side.

- Difference in water level
- Difference in vegetation
- Scour pool
- Bank slumping
- Divergent channel
- Slack water

Creek: 2.6m wide, angular flow, scour pool

Creek: 2.6m wide, angular flow, bank slumping

Comments: Culvert should be replaced with a larger opening to restore a more natural tidal flow.
