**Site CBSS12C:** Cobequid Trail**Date Assessed:** 07/02/02

**GPS Coordinates:** N 45° 20' 50.4''  
W 63° 24' 5.6''

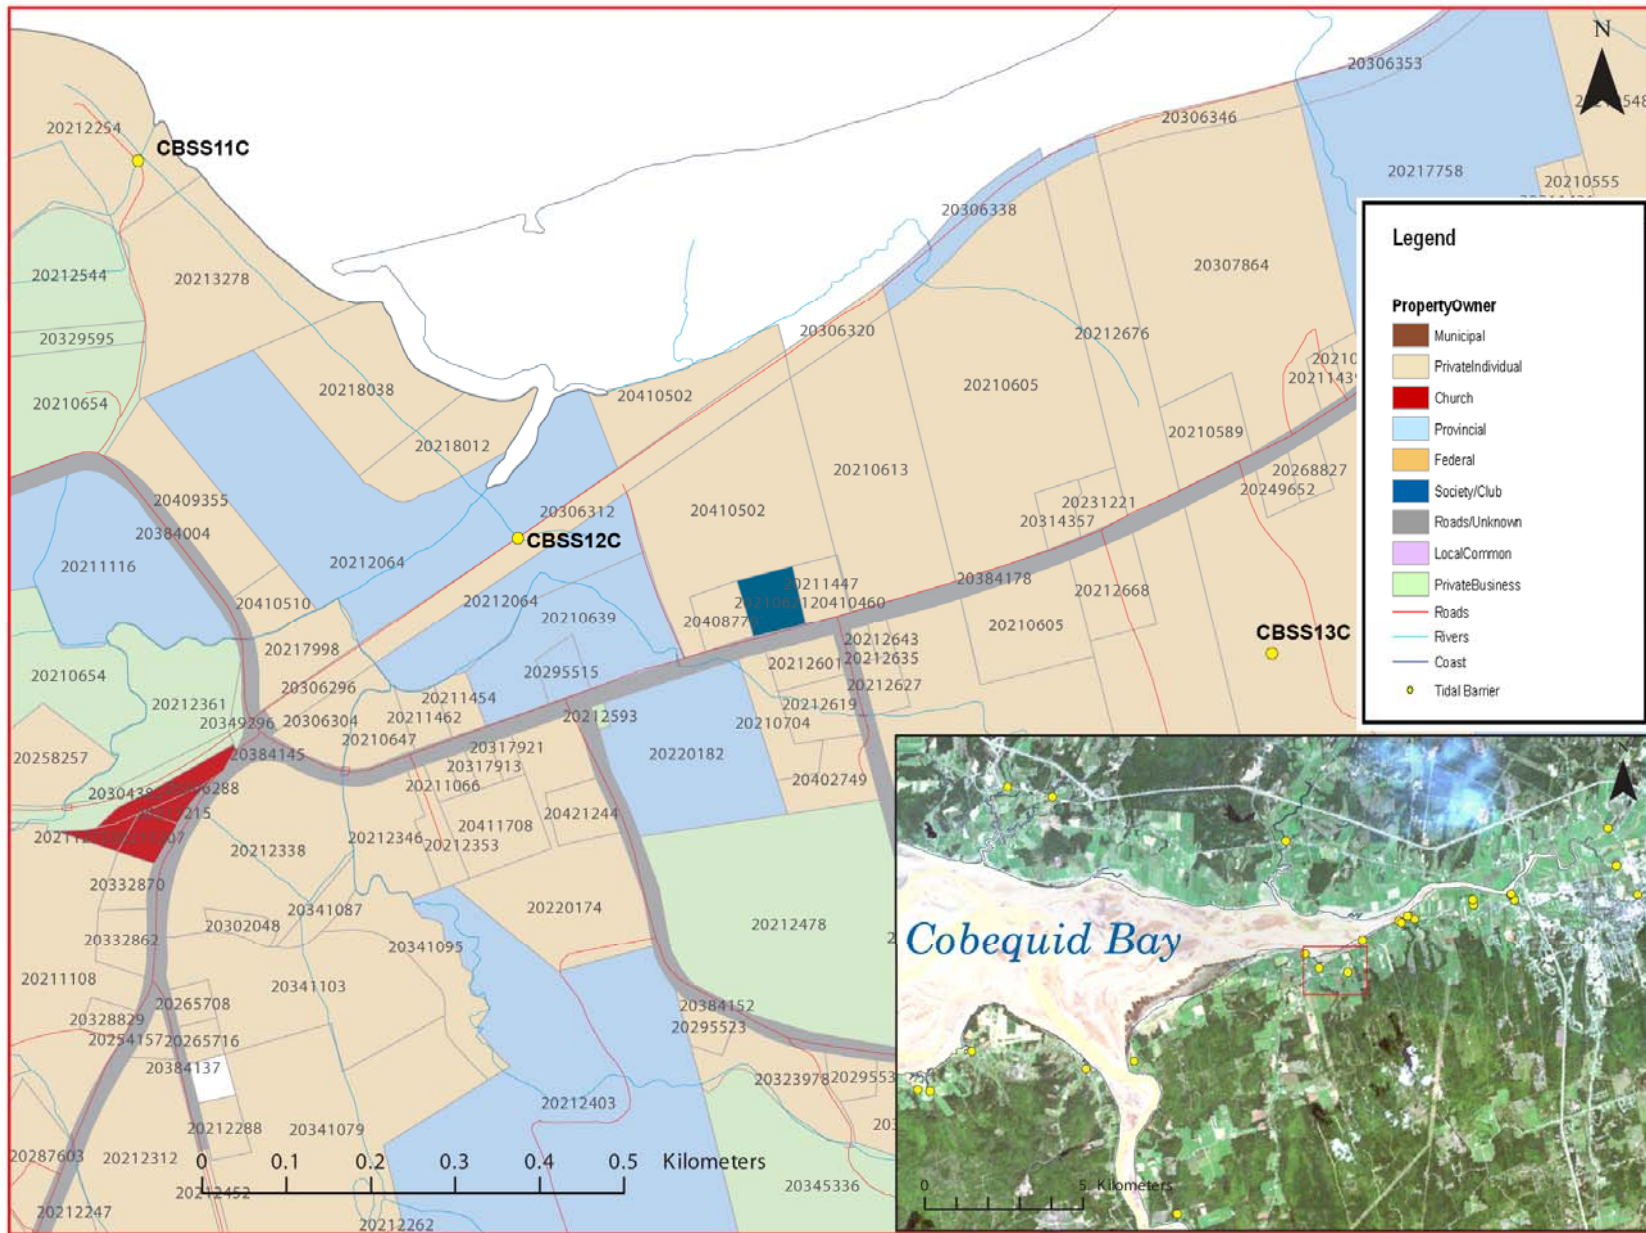
**Figure 1.**

**Crossing Condition:** In poor condition, rusted out and pieces are missing.

**Comments:** Rusting culvert is beginning to collapse and should be replaced with larger opening.
