**Site CBSS7C:** Cobequid Trail

**Date Assessed:** 01/08/03

**Road Crossing:** Culvert, cement, 2.4m wide

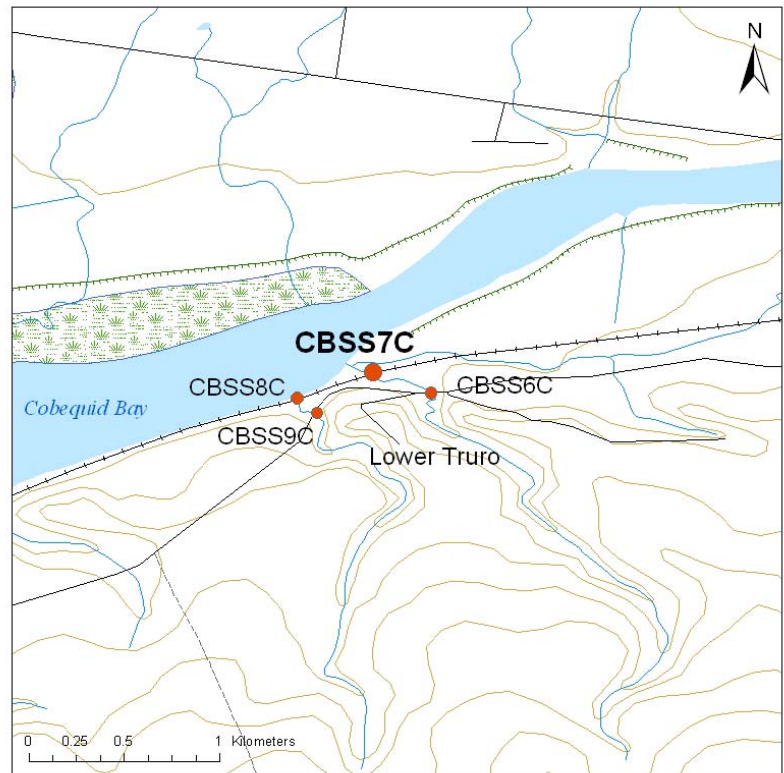
**Crossing Condition:** Structure is intact. Culvert located quite high up along the bank which could interfere with regular water passage. Rock banking around culvert on upstream side to prevent erosion.

**Restriction Indicators:**  
Difference in stream width  
Bank slumping  
Turbulent flow

**Comments:** Replace culvert such that it is located lower on the bank to allow for more regular water flow, which currently only passes through during and close to high tide.
