Site CCCB 10C: Maccan Loop

Date Assessed: July 8, Aug. 27-8,
Nov. 18, 2003

Road Crossing: 1m/1m wooden
culvert (potential aboiteaux).

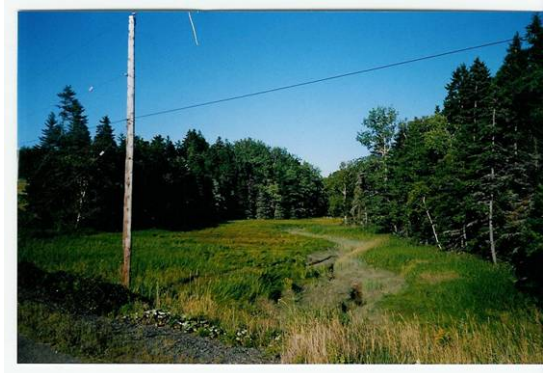
Creek: Creek is 1m wide.

Land: Fallow/wild agricultural land/marsh.

Figure 4. Upstream of the crossing. Photo taken from the road.
