Site DC36B: Duffy Brook

Date Assessed: 26/08/04

Road Crossing: Culvert (concrete) square open bottom, 3m

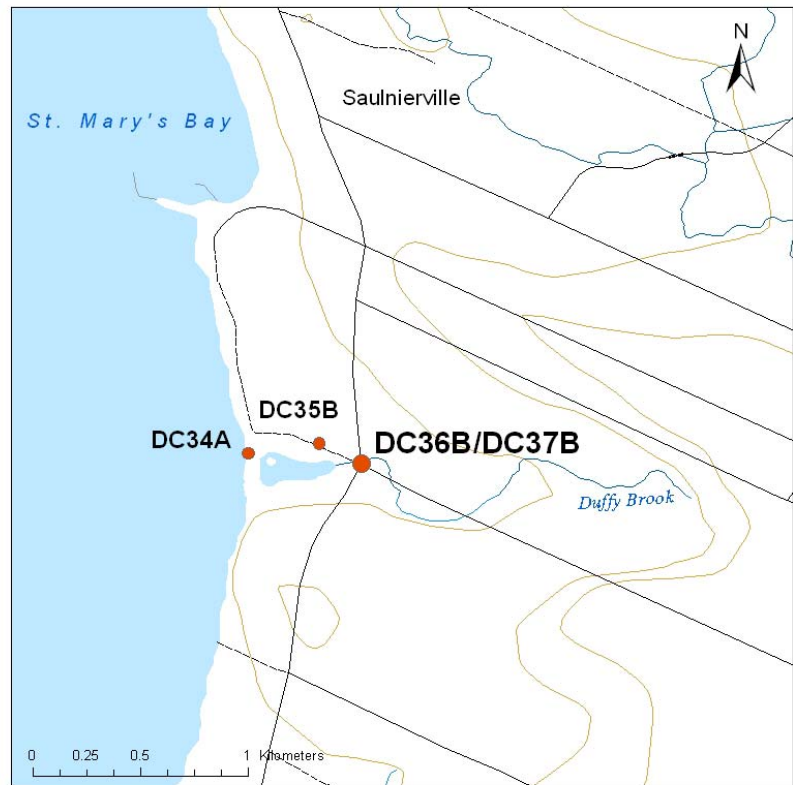
Comments: No marsh restoration potential due to downstream aboiteau. If aboiteau is replaced to allow tidal flow, reassess this crossing. Fish passage is still a factor however this does not appear to be a barrier.

Figure 1. Downstream view of crossing.
