**Site DC7C:** Winchester Point

**Date Assessed:** 30/11/04

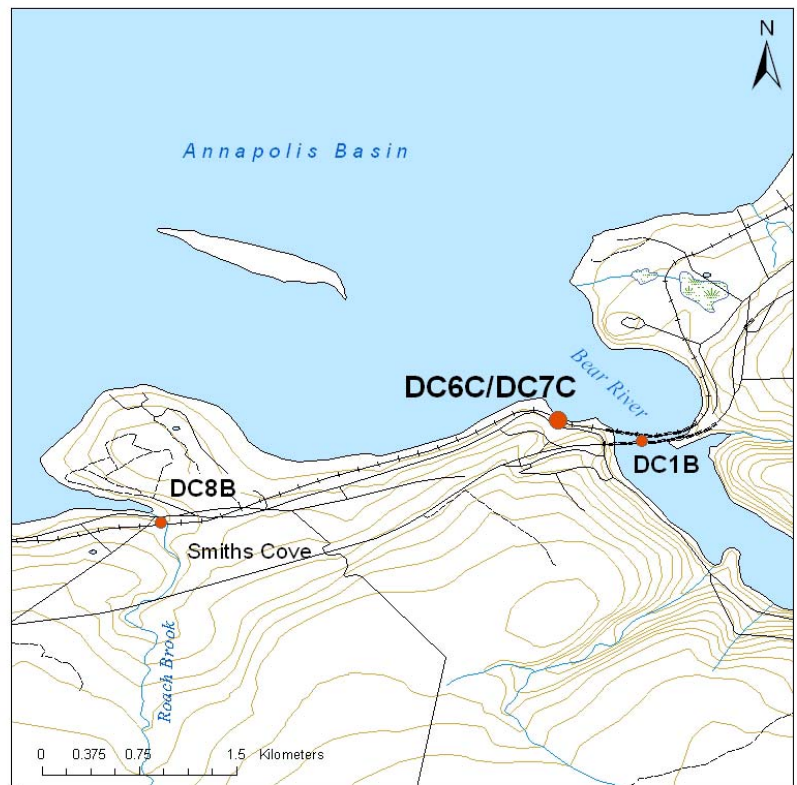
**Crossing Condition:** Intact but rusted

**Creek:** 1m wide, large boulders eroding into creek. Channel flows towards crossing DC6C which is completely blocked by rock, however some water is seeping through.

**Comments:** Should the downstream restriction (DC6C) be opened this culvert would need to be widened as it may then pose as a restriction to tidal exchange. In its current state this culvert is serving as drainage from the upland and from highway 101 culvert.
